FY2025 APPLICATION

DATE SUBMITTED: October 24, 2023
NAME OF PROJECT: Structural Restoration of the Steeple on Historic Property
NAME OF APPLICANT: First Parish Northborough Unitarian-Universalist Church
CONTACT ADDRESS: 40 Church Street, Northborough, MA
CONTACT TELEPHONE: 913-219-7394
CONTACT EMAIL ADDRESS: gordonhart@gmail.com
SPONSORING ORGANIZATION: First Parish Church
CPA CATEGORY: <input type="checkbox"/> OPEN SPACE/RECREATION <input type="checkbox"/> HOUSING <input checked="" type="checkbox"/> HISTORIC
LOCATION: <input type="checkbox"/> TOWN LAND <input type="checkbox"/> SCHOOL LAND <input checked="" type="checkbox"/> PRIVATE LAND
AMOUNT OF CPA FUNDS REQUESTED: \$210,000
OTHER FUNDING SOURCES: Massachusetts Preservation Projects Fund, and Church
TOTAL COST OF PROJECT: \$300,000
BRIEF DESCRIPTION OF PROJECT, INCLUDING ANY CONSTRUCTION REQUIRED:
<p>The steeple continues to suffer from rainwater leakage. The congregation plans, at its own expense, to hire a contractor to replace defective materials on the steeple exterior and reseal that exterior to prevent future leakage. It hopes to have this work completed by the end of the calendar year, 2023. This steeple is part of our M

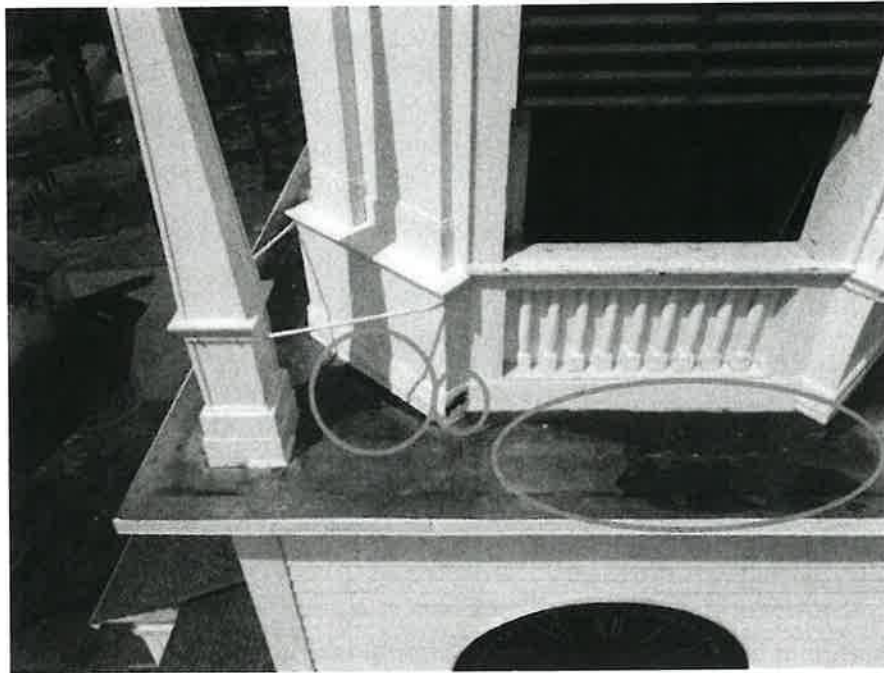
- At the south elevation, we found standing water that was in contact with the wooden baseboard below the balustrade. There was also a rotted hole in the wood trim that appears have be worsening due to constant exposure to water (Photo 1).
- We found more standing water along the north, east, southeast, southwest, west, and northwest faces of the belfry level. With standing water alongside almost all of the wooden exterior trim at the belfry level, and only sealant or flashing with a few inches of height to protect the wood, water can easily reach the internal structure under wind-driven or slushy conditions (Photo 2-4).
- The sealant bond is visibly broken at the north, east, and west faces, with some detached flashing visible at the north façade (Photos 2-4).

Photo 1: Standing water and opening at the south face belfry level

First, the present rubber membrane should be stripped and the wood skirt boards that run over the backs of the roofed surfaces and the bases of the pinnacles should be removed. The roof surfaces should be re-pitched with pressure-treated (P/T) wood plywood on P/T wood furring to create a more aggressive outward pitch. These surfaces should then be re-roofed with red or zinc-coated copper that is run at least 8" up the faces of the sheathing and/or backing boards behind the removed trim. The trim boards should then be rip-cut to a narrower width and then reinstalled over the up-turned sheet copper roofing to eliminate the possibility of overtopping the flashing.

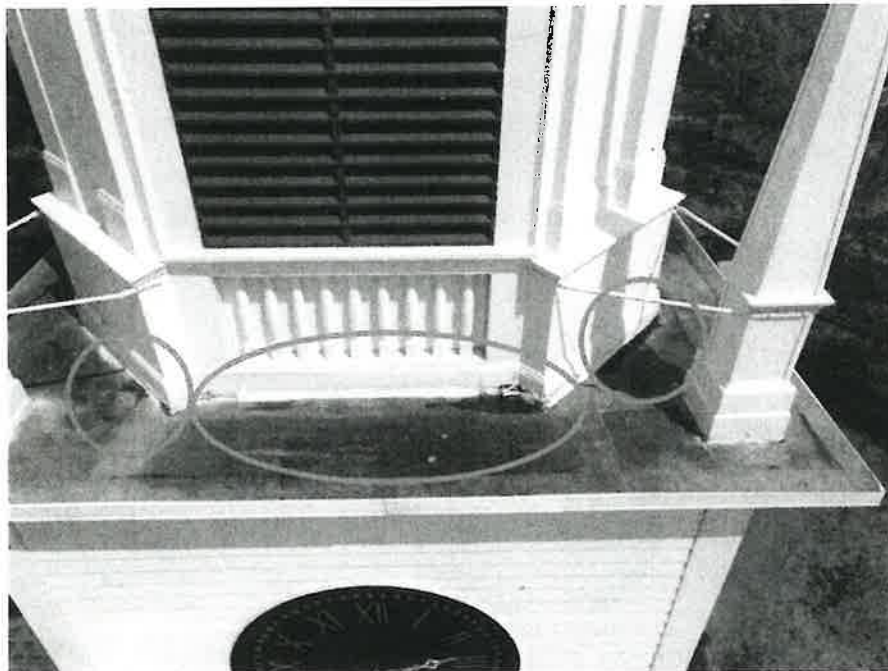
Photo 2: Standing water and deteriorating sealant at the west face belfry level

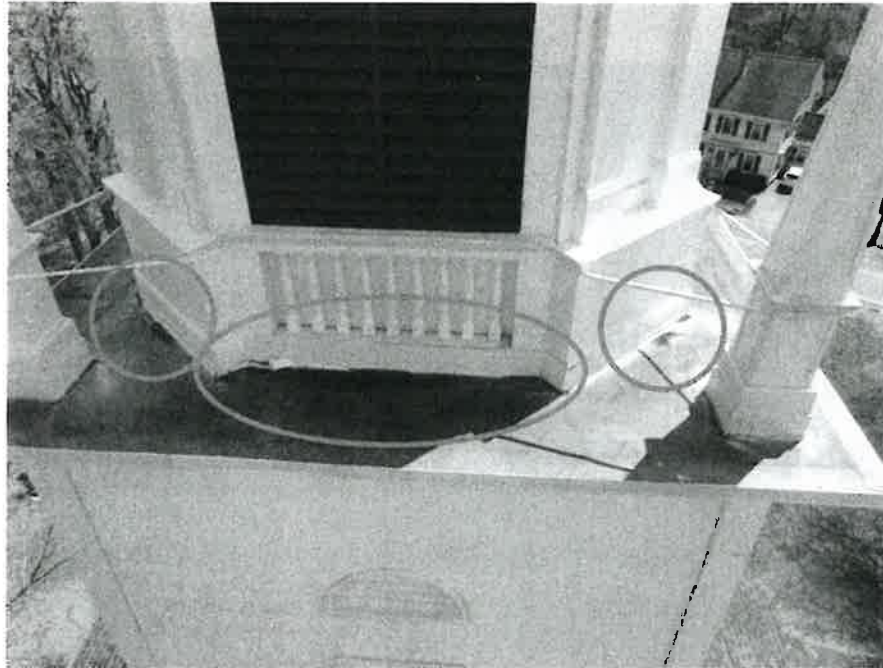
Photo 3: Standing water and detached sealant/flashing at the north face belfry level

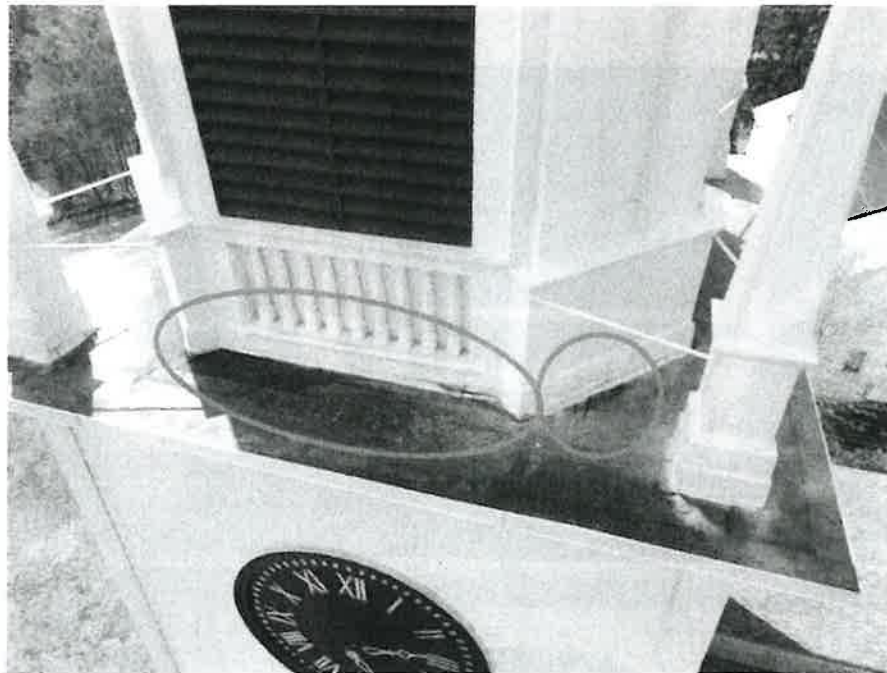
Photo 4: Standing water and detached sealant/flashing at east face belfry level

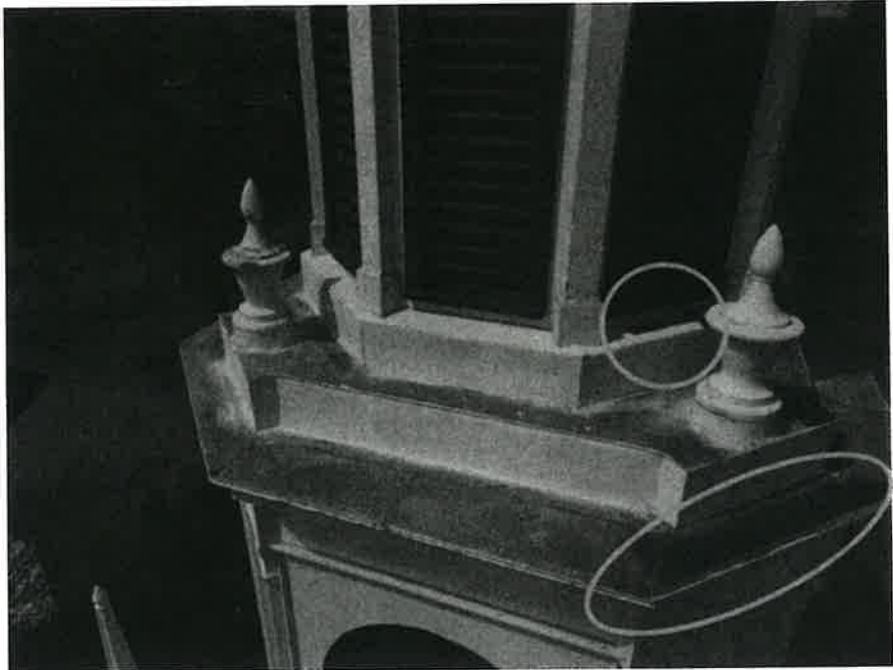
- We found pooling water at the southeast, north, and west faces of the lantern level (Photos 5-7).

- A hammer was found just outside of the southeast louver (Photo 5) but could not be reached safely without climbing gear. *The hammer should be removed immediately to avoid any potential injury or unsafe circumstances.*

Photo 5: Standing water and hammer along the southeast face of the lantern level

Just as we recommended for the belfry level, the present skirt boards and roofing should be stripped and the roof re-pitched as noted above. The small pinnacles should also be removed. The stepped roof should then be re-clad in red or zinc-coated copper, which flashing should extend up no less than 8" over the wood

sheathing at both the flat roof and the raised step, with the outer edges formed with a hemmed drip. The skirt boards should then be reinstalled, along with the small pinnacles, which should be set on raised flashed bases that are fastened through the copper to the wood structure below and keep the pinnacles dry. All rotted wood should be replaced.

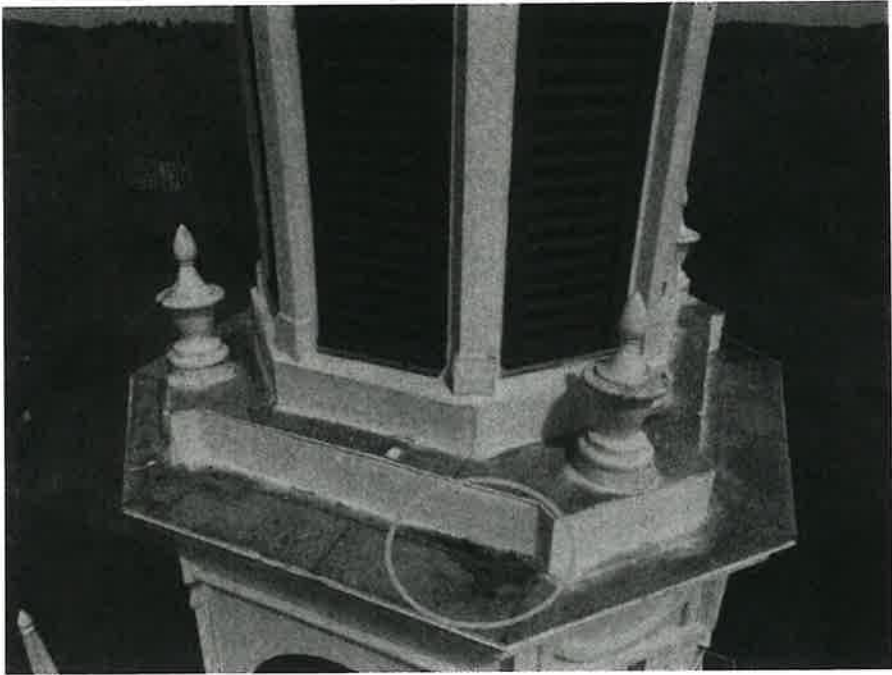
Photo 6: Standing water along the west face of the lantern level

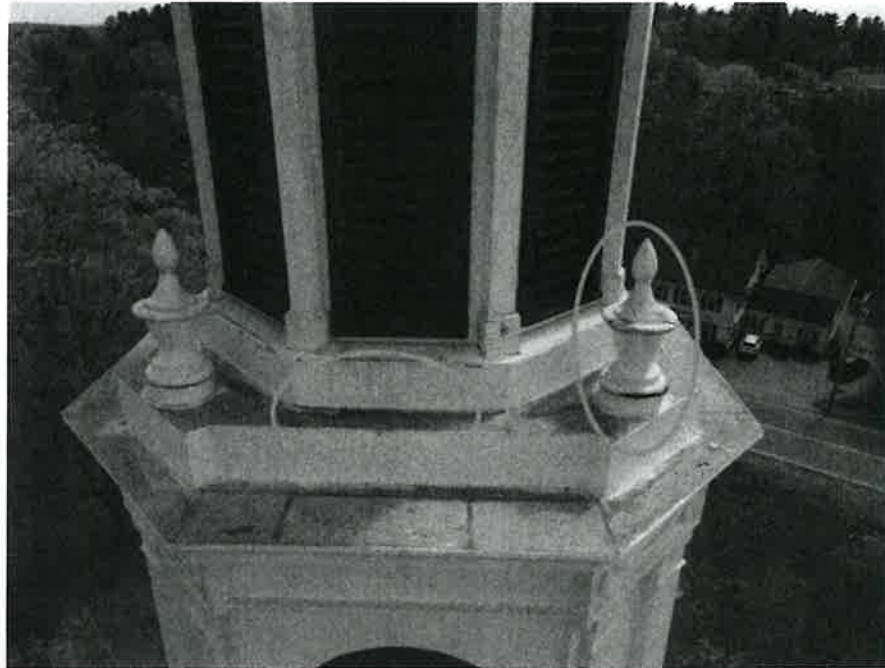
Photo 7: Standing water and deteriorating pinnacles along the north face of the lantern level

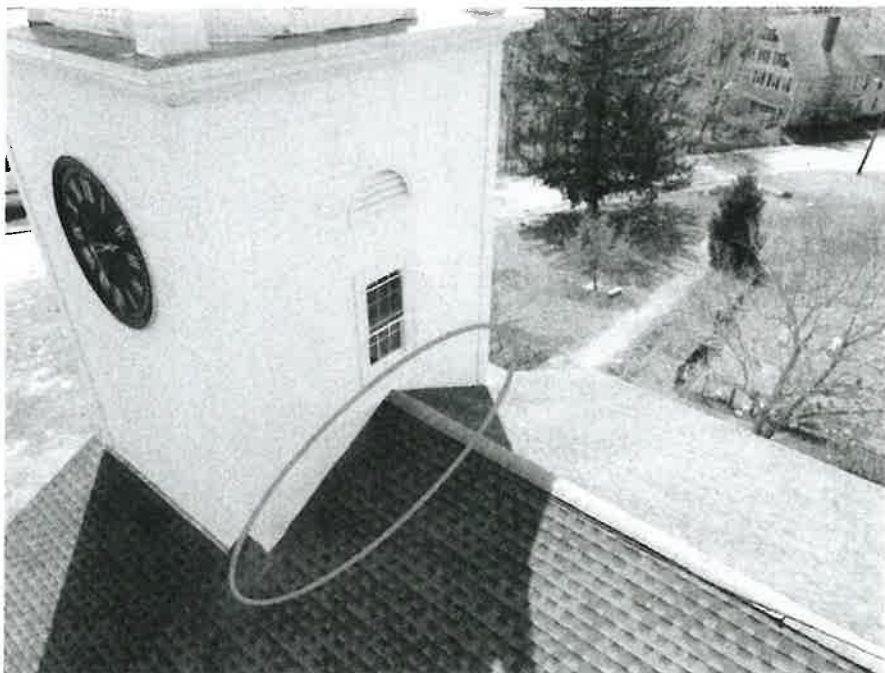
Additional concerns are present at the north and south sides of the tower where the peak of the church's roof meets the base of the tower. This area should be inspected further to see if there is already flashing present behind the vinyl siding (Photos 8 and 9). If there is no flashing, part of the siding and roofing shingles should be removed for proper copper flashing installation which includes red or zinc coated copper step flashing that runs up the sheathing behind the siding and trim boards.

Photo 8: Suspect area with potential need for flashing (north face of tower)

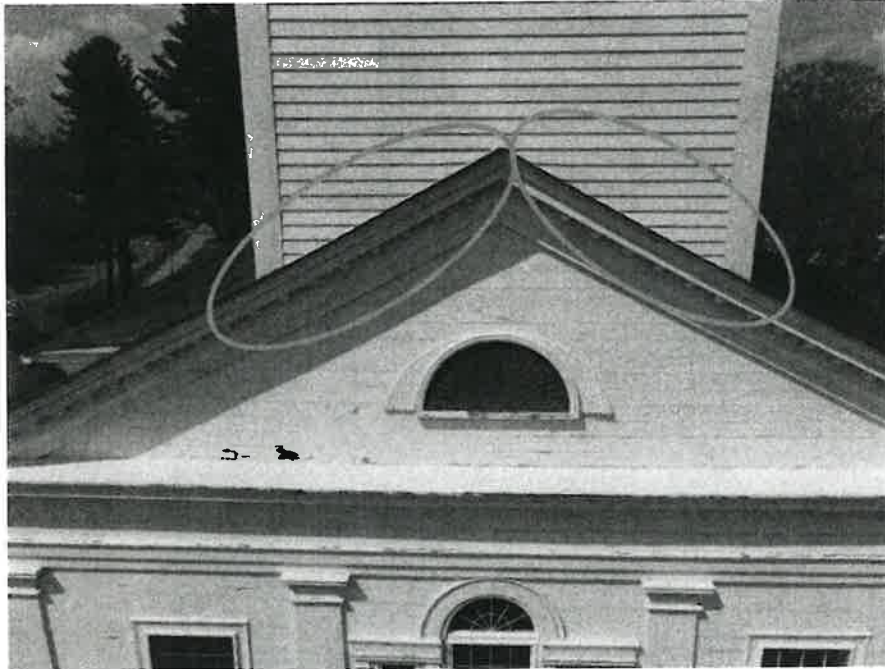
Photo 9: Suspect area with potential need for flashing (south face of tower)

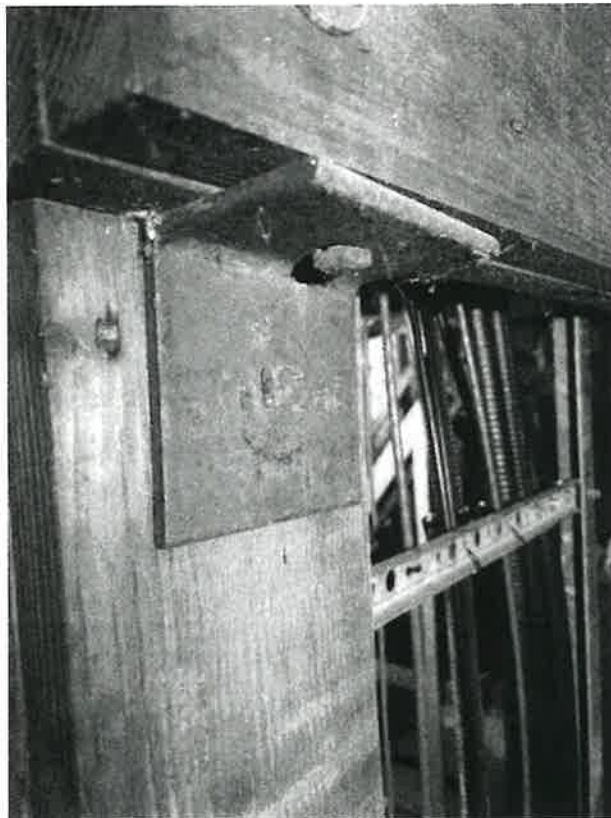
- Metal connecting angles were installed at some of the horizontal (4) 2x8s and (2) 2x12s that are located near the tops of the posts at level A (Photo 10). Along the north side, the through bolts that connect the angle to the posts do not run all the way through and only engage (1) of the several 2x8s. This means that not all of the 2x6s that make up the post are engaged, and neither are the 2x8s, which reduces the capacity of the bracing connection.

Photo 10: Poor brace to post connection

The bracing connections will need further reinforcement to activate the entirety of the post cross section, either with an added steel gusset plate or a different type of connection.

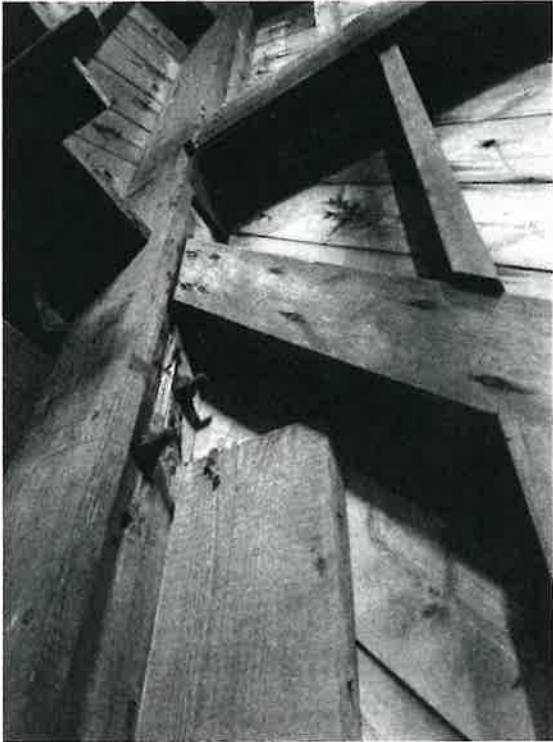
- We found deformation and surface splitting in the southeast post in between (2) through bolts that connect the (2) 2x12s to the post (Photo 11). This is a common sign of localized overstress or hidden rot that is causing load to shift to the front face of the member. *This portion of the post should be structurally analyzed and probed in further detail to determine the exact cause of this damage, which should be addressed.*

Photo 11: Splitting at the southeast post connection

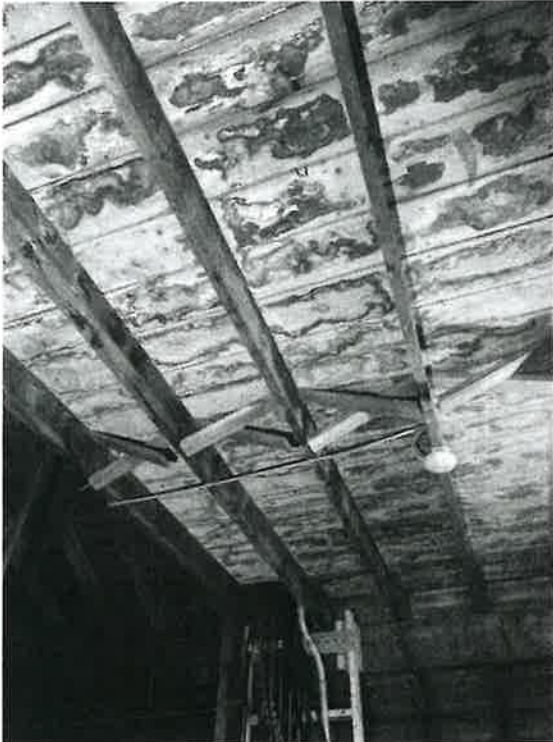
- Between the joists, there was diagonal blocking, located near to their midspan (Photo 12). All of the blocking was disconnected from the joists, left to hang only from their top connection. *All of the blocking should be reattached to the joists.*

Photo 12: Detached diagonal blocking between joists

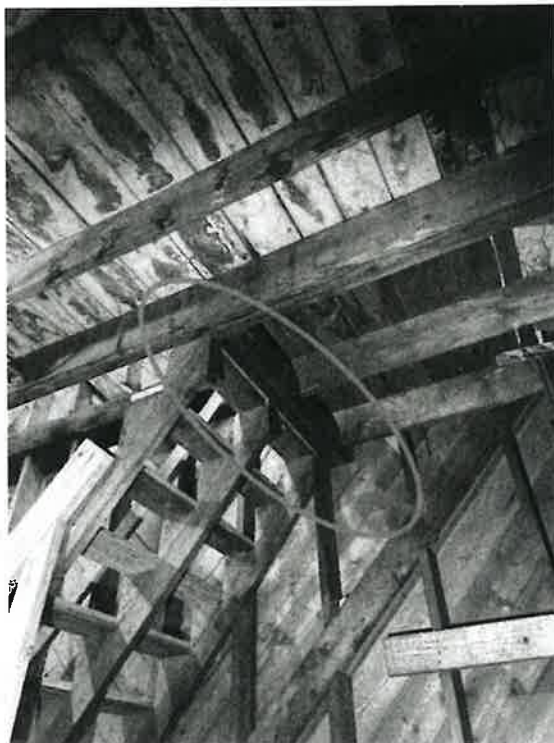
- At the west end of the framed stair opening, there are (3) 2x8s laminated together, acting as a header (Photo 13). The (2) joists that are supported by the header are notched at their end connection. When joists are notched along their underside, a stress concentration builds up at the inside corner of the notch and cause a horizontal crack through the joist member, thus weakening it. *Standard metal face-mount hangers should be installed at the notched ends so that the full depth of the joist is engaged.*

- The (3) 2x8 stair header also appears to have poor end connections, having only been toenailed in at each end. *A metal hanger should be installed at the end of the header where it meets the joists and should be posted down where it is currently toenailed into the sheathing.*

Photo 13: Notched joists and poor header connections

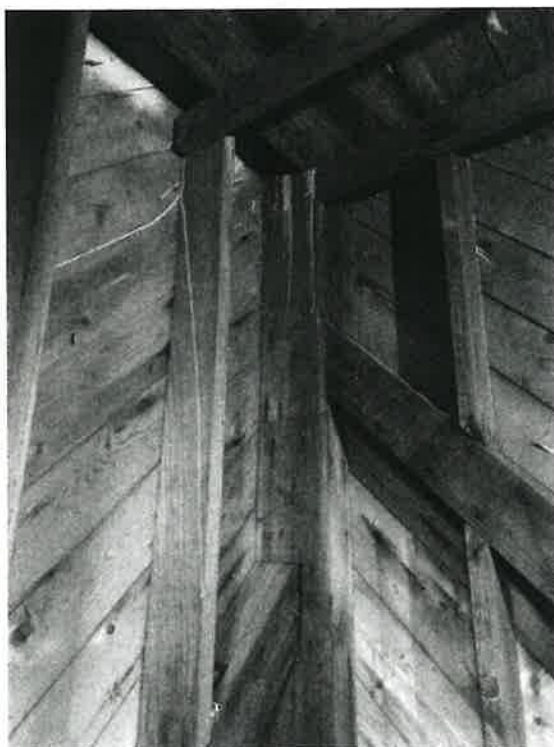
- The vertical studs are toenailed into the diagonal braces and the diagonal braces are either toe nailed into the posts, or only have a single through bolt engaging (1) of the 2x's connecting it to the post (Photo 14). These are poor connections that do not appear to be sufficient to resist the high wind loads, such as from a hurricane. *The stud and bracing connections should be reinforced with steel gussets and nailed straps to strengthen the end connections of the lateral bracing system.*

Photo 14: Toe nailed stud connections and minimal bracing connections

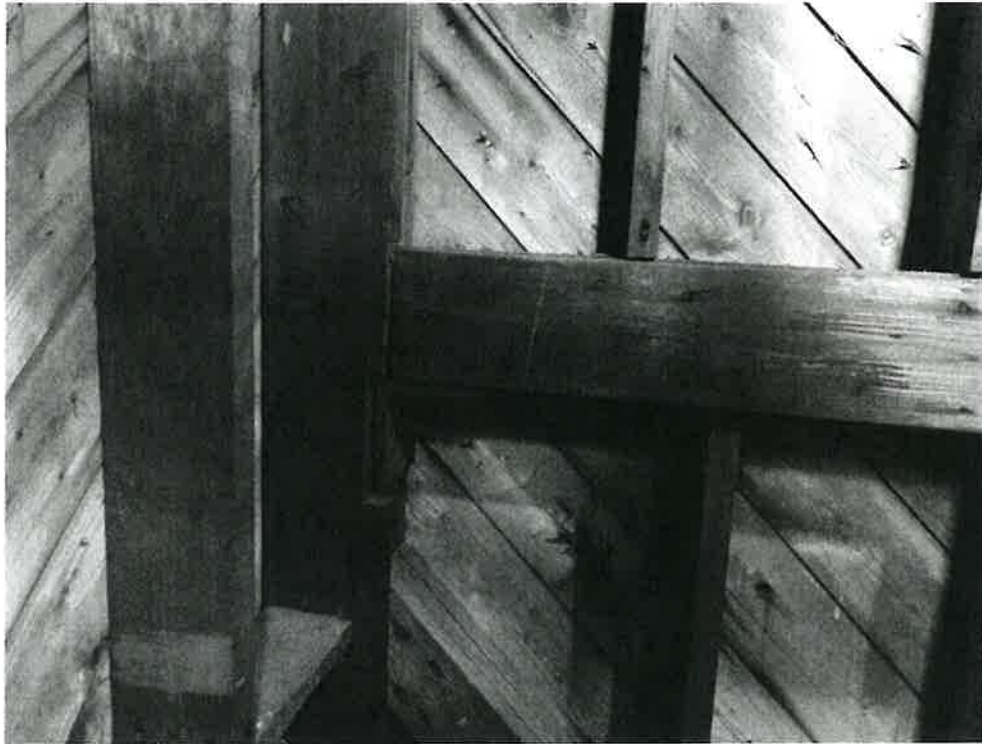
- Similar to level A, the horizontal bracing members at the north and south ends of the tower have metal angles that are minimally connected to the posts (Photo 15). *These connections will need to be reinforced with added steel gussets or replaced with stronger connections.*

Photo 15: Poor horizontal bracing to post connections

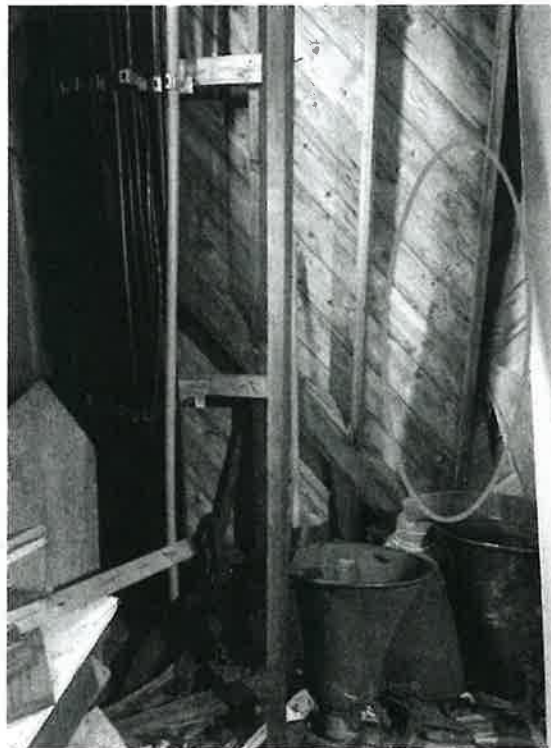
- We found some water staining on the west face sheathing (Photo 16), which can often suggest early stages of rot. This is most likely occurring from the water infiltration seen at the higher tower levels. *This level should be monitored for additional water damage after water resistant methods are adopted, as discussed in the "Exterior Conditions" section.*

Photo 16: Slight water staining at level #1 west wall

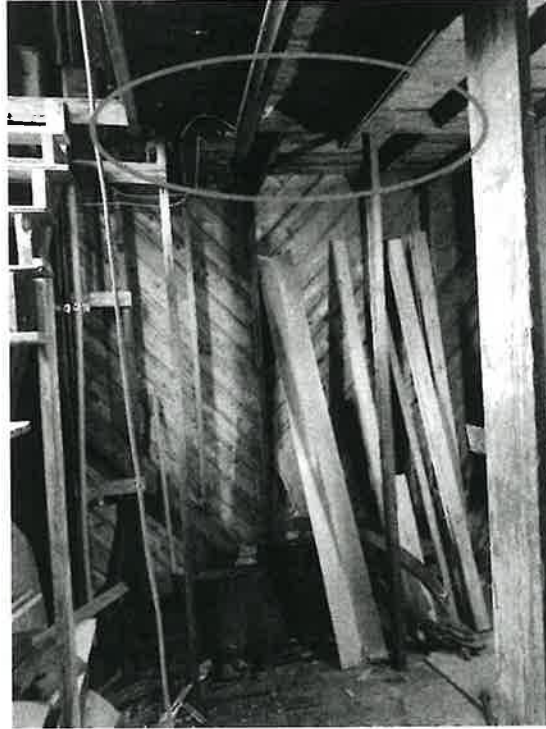
- The long spanning 2x4s have a visible sag due to being overstressed in bending, as well as the water damage that is present.
- The framing in the middle bay (3 joist bays in total) has a variety of joist sizes starting from 2x4s extending up to a 2x10. The joists that are 2x4 are only toenailed into the 2x4 "beam", which is a poor connection. Additionally, the connections for the larger joists are worse because only the top part of the joist can be connected to the 2x4 "beam", therefore the entire joist cross section is not fully engaged (Photo 17).

Photo 17: Poorly sized joists and beam members at level #2 floor framing

This platform should be reframed and sized properly to safely support human access loads. The joists and beams should connect to the tower bracing members, rather than the sheathing. End connections should sufficiently engage the entire joist cross section. This should be done after the water infiltration has been stopped, so as not to damage the new work.

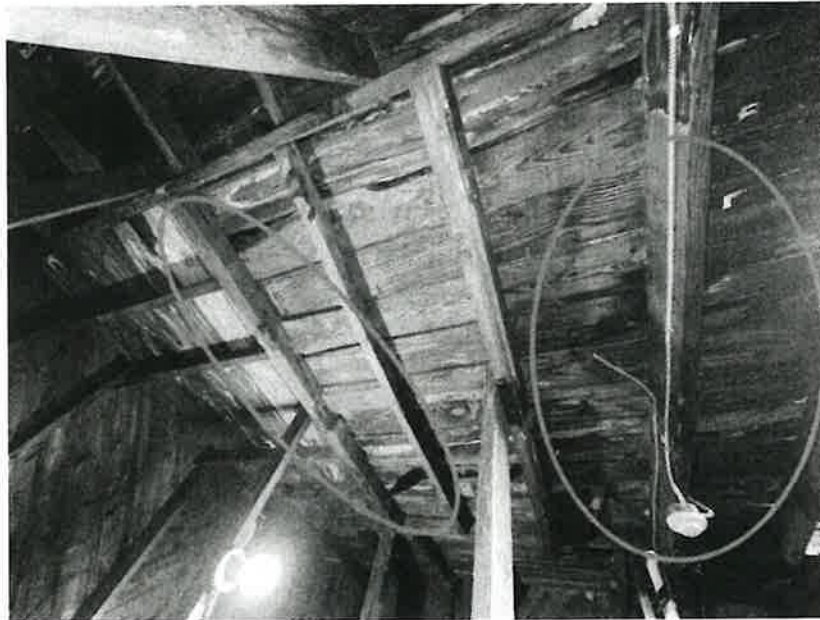
- There are significant amounts of water staining and visible rot along the level #2 floor planks and framing. There are some areas where there are deteriorated openings in the floor planks, making it unsafe to walk on. A few areas have heavily eroded planks that are currently "punk", and on the track to developing holes too (Photo 18).

- One of the (2) 2x4 headers has a discontinuous member which weakens the header's bending capacity, and the overall floor strength (Photo 18).

Photo 18: Water damaged floor planks and cut floor joist on level #2 floor framing

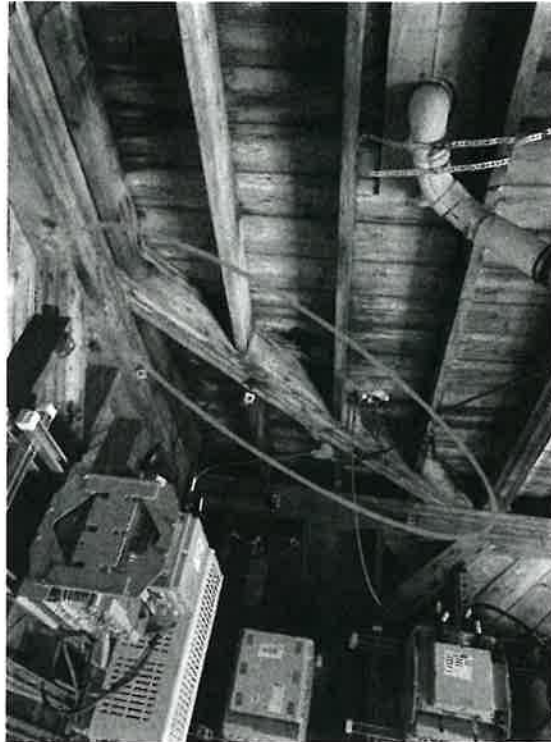
- At the time of our inspection, we suspected that there was rot present in the diagonal floor bracing beams, based upon water staining and mold growth on the members, so we performed resistance drill tests at the southwest corner one, which was the most accessible of the four. Our tests showed that there is rot present within the beam cross section, therefore we anticipate that there is rot present at all four of the diagonal bracing beams (Photo 19).

- The joist ends that are intersected by the bracing beams are only toe nailed to the beams (Photo 19). *The joist ends should be reinforced with skewed face-mount hangers.*

Photo 19: Belfry framing rotted bracing beams and poor joist end connections

Further inspection is required, once conditions are made safe, to determine the severity of the rot at each of the bracing beams and whether replacement or additional reinforcement is required.

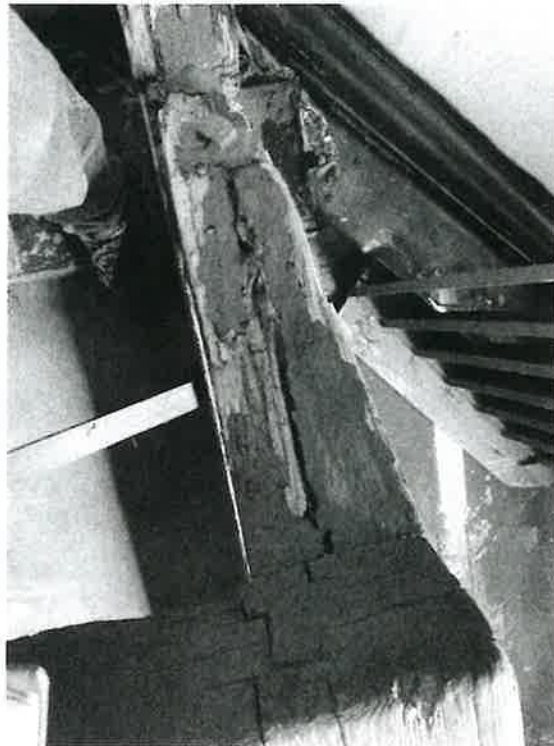
- The south end of the bell cradle, made up of 6x8 timbers has signs of rot on two of the four timbers at the south end (Photo 20). *These members should be replaced before the cradle system becomes insufficient to hold the weight of the bell, making an unsafe situation for occupants below.*
- The (4) rods that are at each corner of the bell cradle are visibly loose (Photo 21). *These rods should be tightened to actively engage them back into tension.*

Photo 20: Rotted leg of the south end of the bell cradle

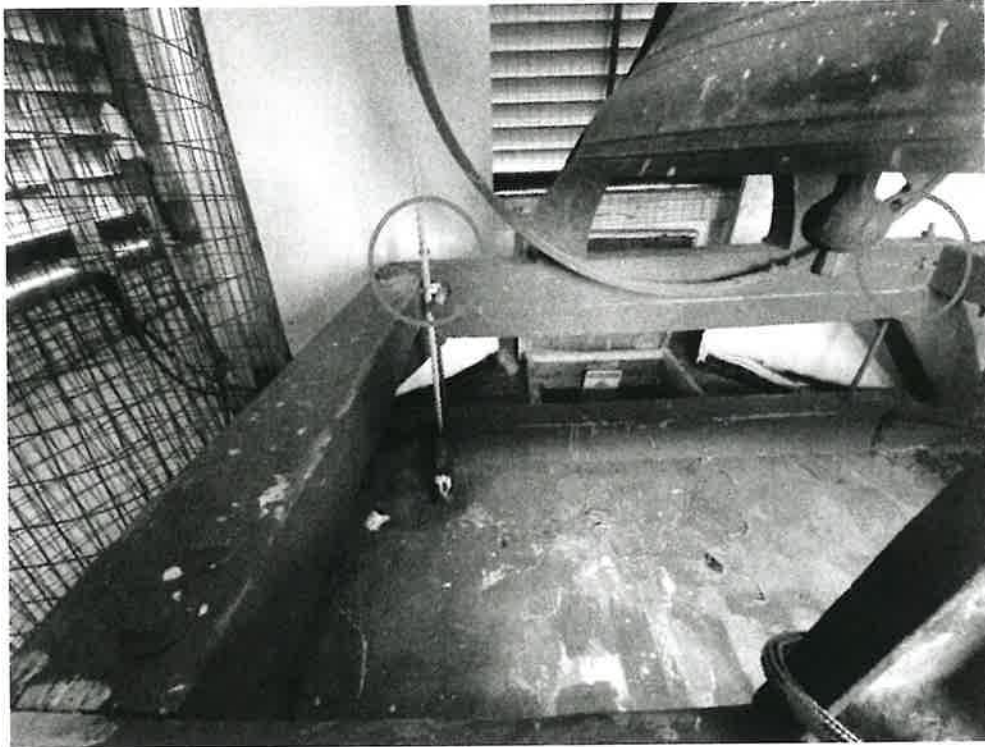
Photo 21: (2 of 4) Loose tension rods on the bell cradle

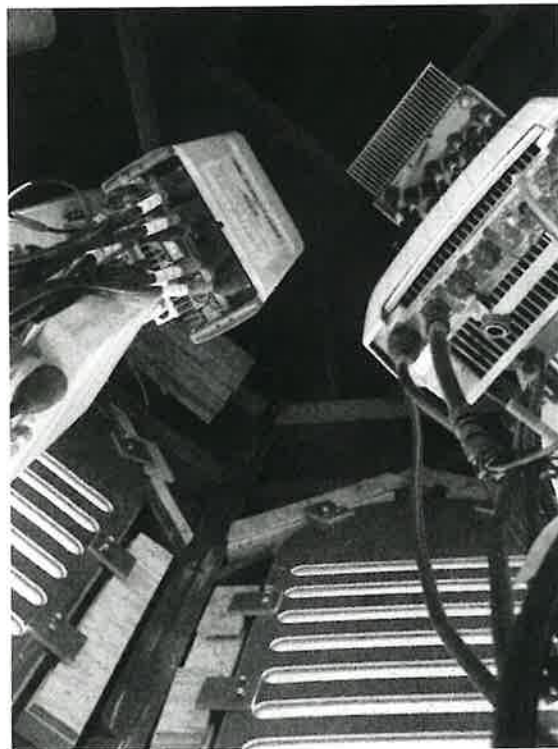
The lantern level houses cellular equipment within. Most of the wall system was visible, consisting of (2) 2x4 posts and newer 2x4 plywood "gussets" to replace the original 2x4 diagonal braces that were cut to fit in the louvers (Photo 22). We did not find significant damage at this level.

Photo 22: Cut original bracing and new wood "gusset plates"
