Northborough, MA
White Cliffs Mansion
Assessment and Reuse Study

Submitted To:

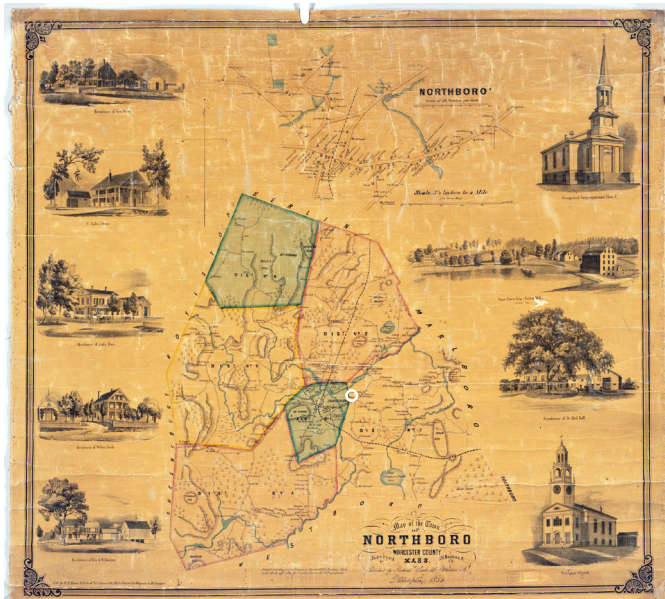
Figure 1.5: Map of Northborough with vignettes of prominent buildings, 1855. Future location of White Cliffs noted in white.

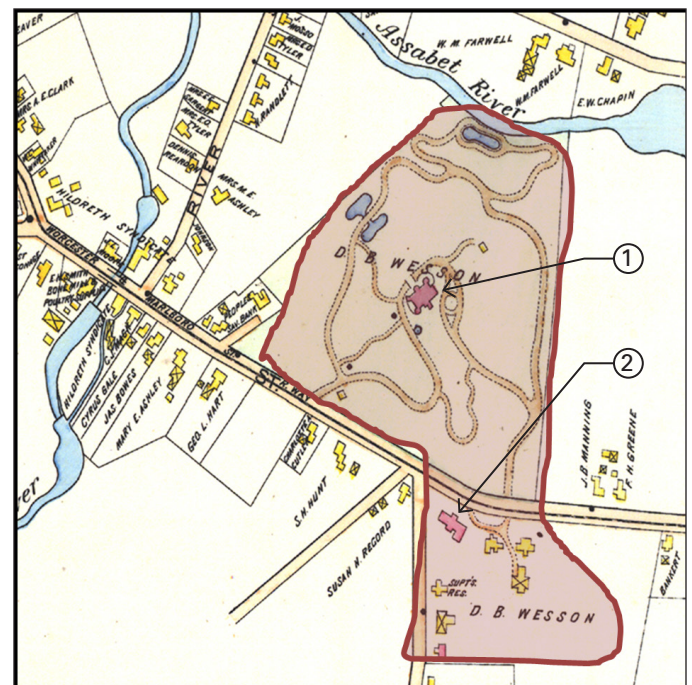
Figure 1.7: Map with The Cliffs properties indicated, c. 1898. Note 1: location of The Cliffs, Note 2: location of greenhouse.

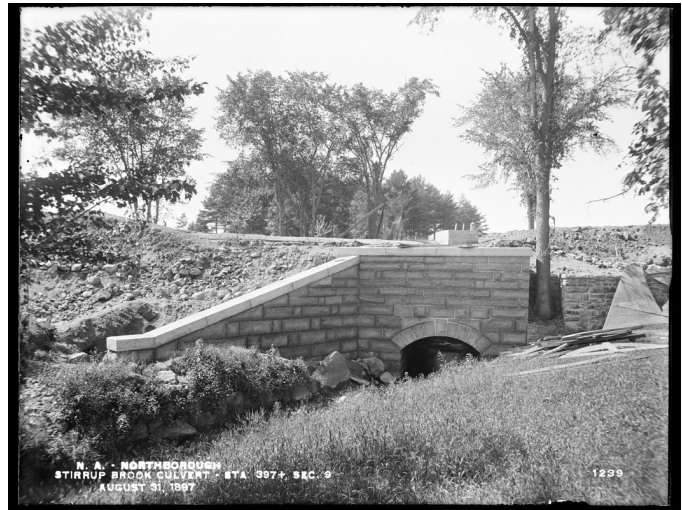
Figure 1.8: Part of The Cliffs' water system, 1897.
Source: Town of Northborough.

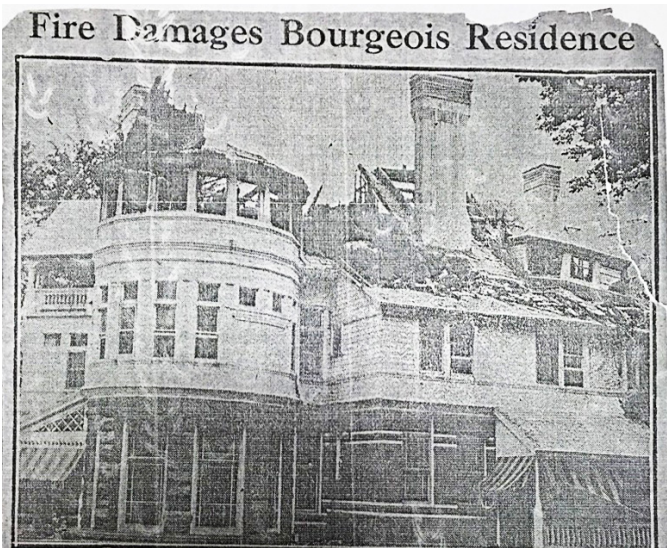
Figure 1.13: Newspaper photo of fire damage, 1931.
Source: Northborough Historical Society.

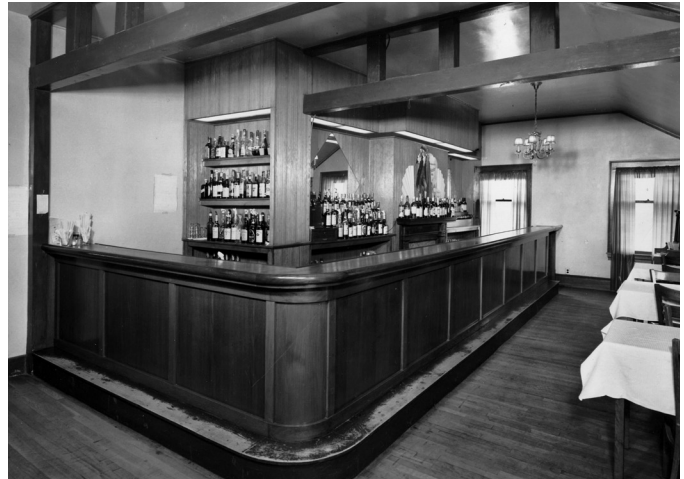
Figure 1.15: Second floor bar at northeast corner, c. 1946.
Source: Northborough Historical Society.

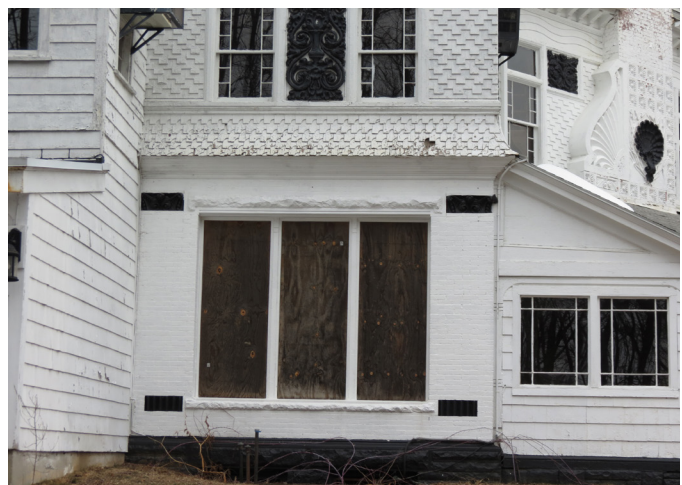
Figure 2.4: Brick masonry and brownstone foundation at southwest bay (painted).

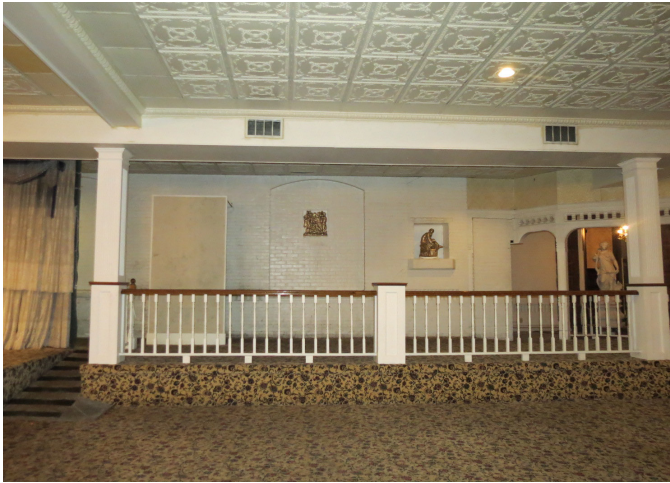
Figure 2.5: Brick wall with infilled window openings at the now interior north facade.

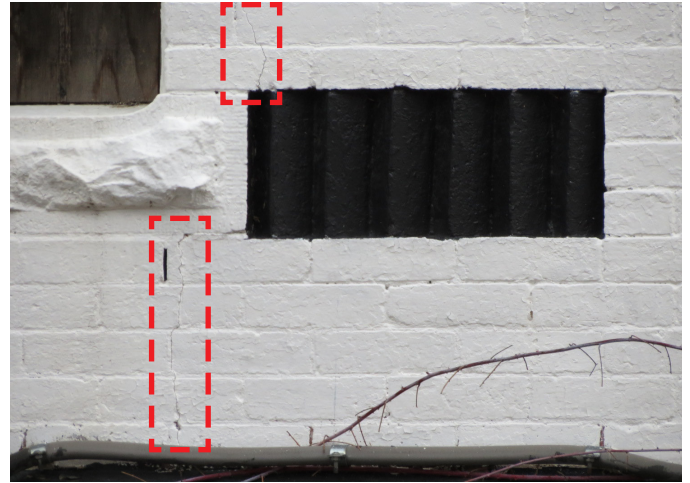
Figure 2.8: Decorative brownstone sill (left), rotated brick band course (center), and brick unit cracks (indicated).

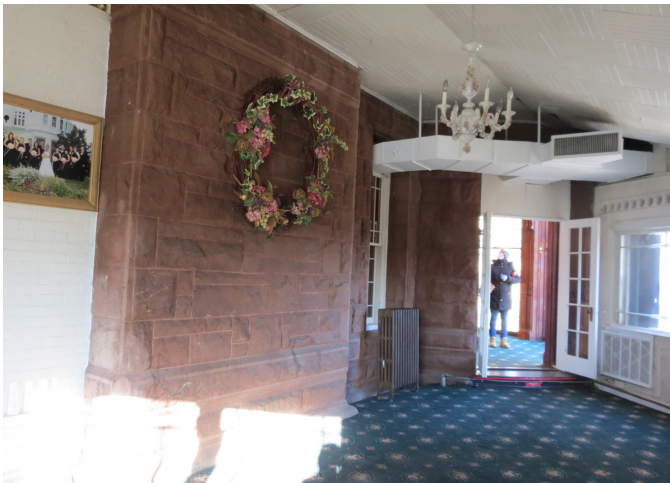
Figure 2.6: Exposed brownstone at the south elevation, inside porch.

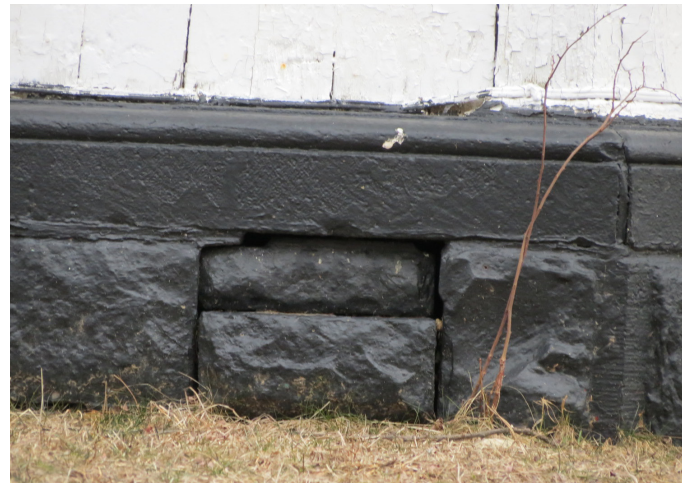
Figure 2.9: Displaced brownstone units at south foundation.

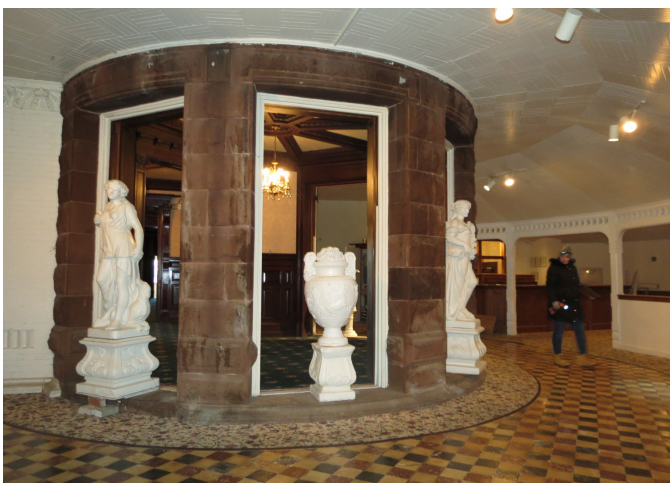
Figure 2.7: Exposed brownstone at the northwest turret, inside porch.

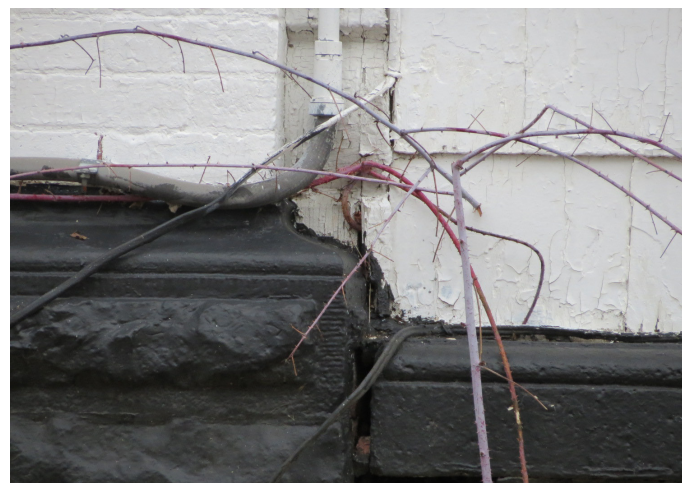
Figure 2.10: Open joint between brownstone foundation and porch construction.

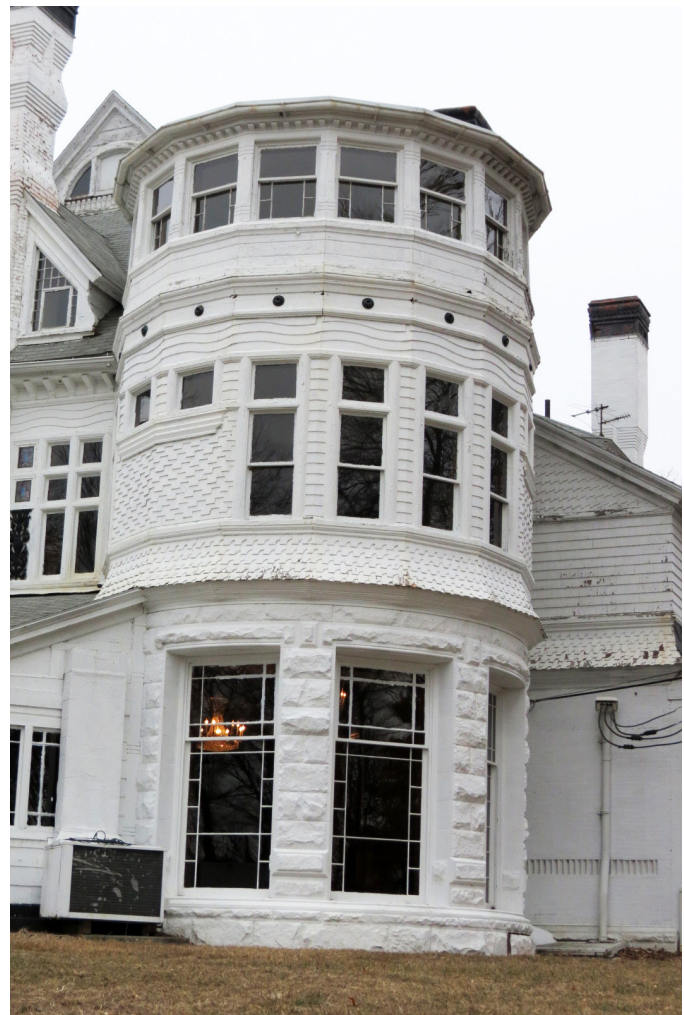
Figure 2.11: Southeast turret with four distinct shingle patterns exhibiting moderate deterioration.

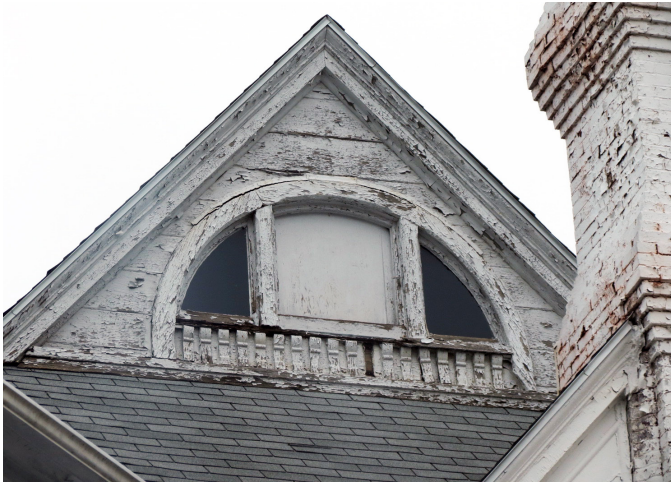
Figure 2.12: Typical deterioration at the upper gable of the south elevation.

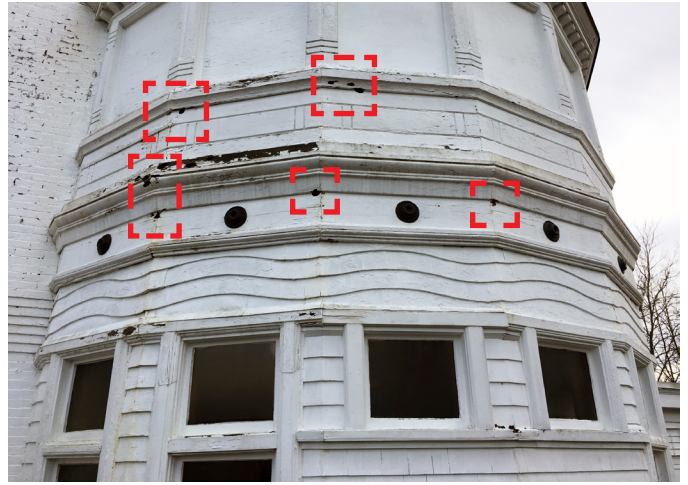
Figure 2.15: Woodpecker holes (indicated) at the northwest turret.

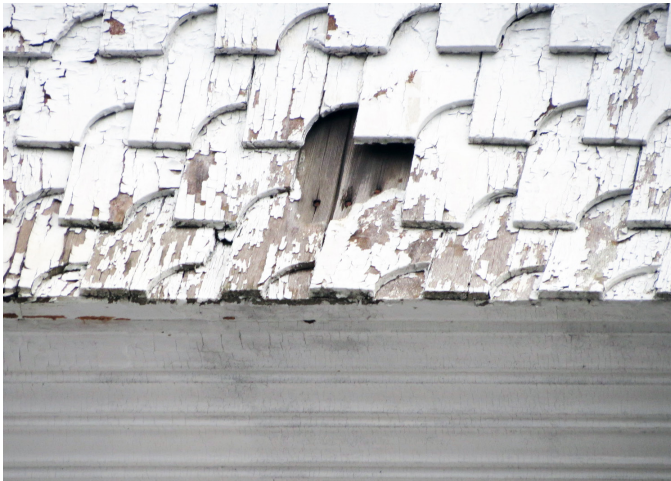
Figure 2.13: Severe deterioration at flared siding at the base of the second floor.

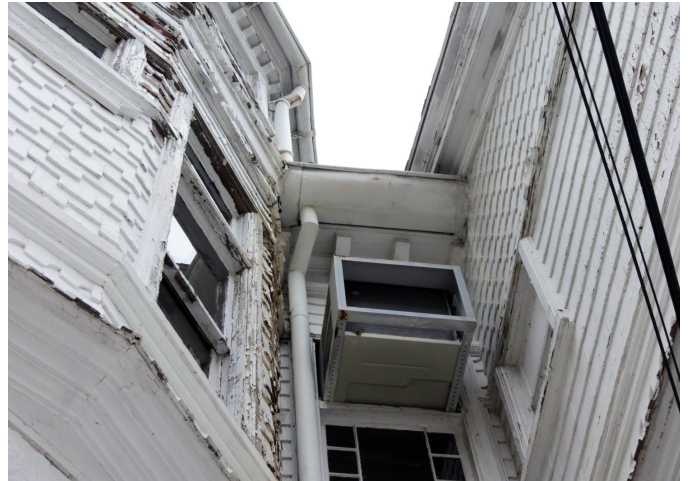
Figure 2.16: Severe deterioration adjacent to an undersized gutter.

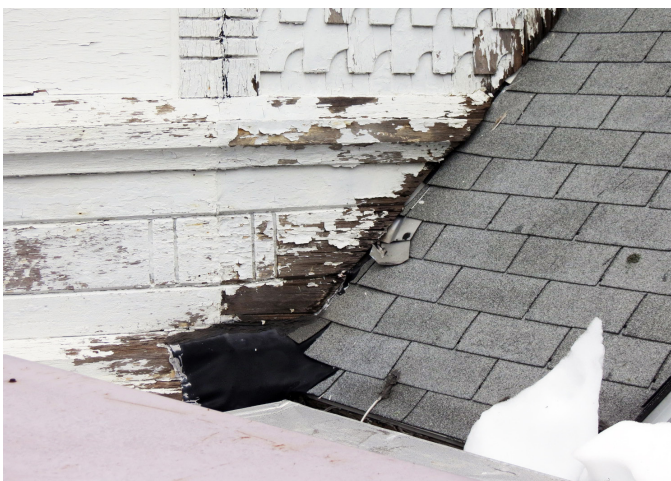
Figure 2.14: Severe deterioration at a siding-to-roof intersection.

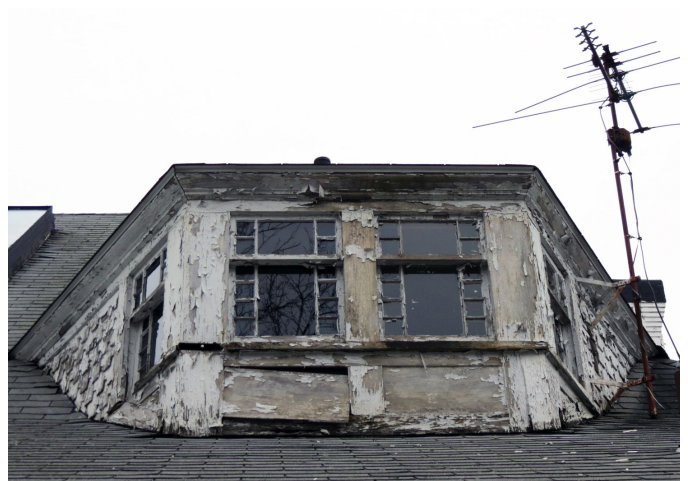
Figure 2.17: Severe deterioration of all wood components at the east dormer.

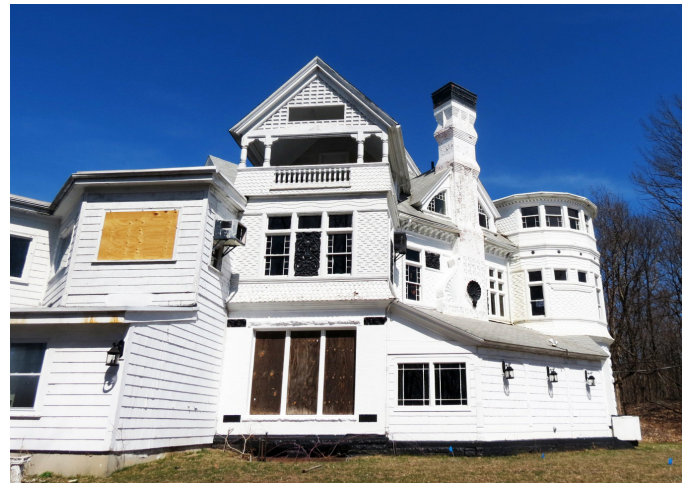
Figure 2.18: View from southwest depicting many window sizes and several removals.

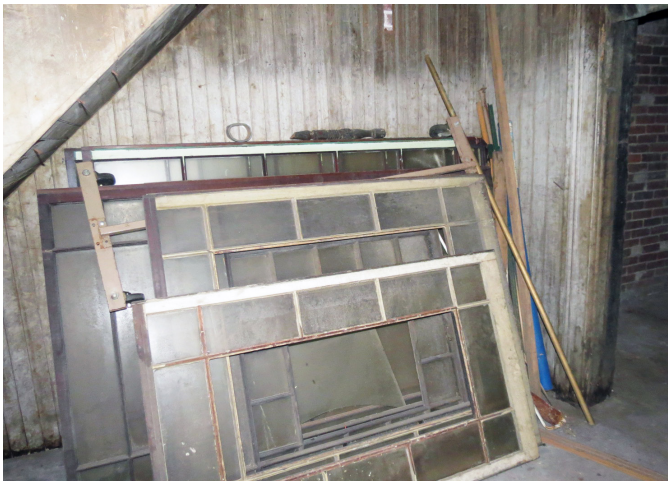
Figure 2.22: Removed windows in the basement.

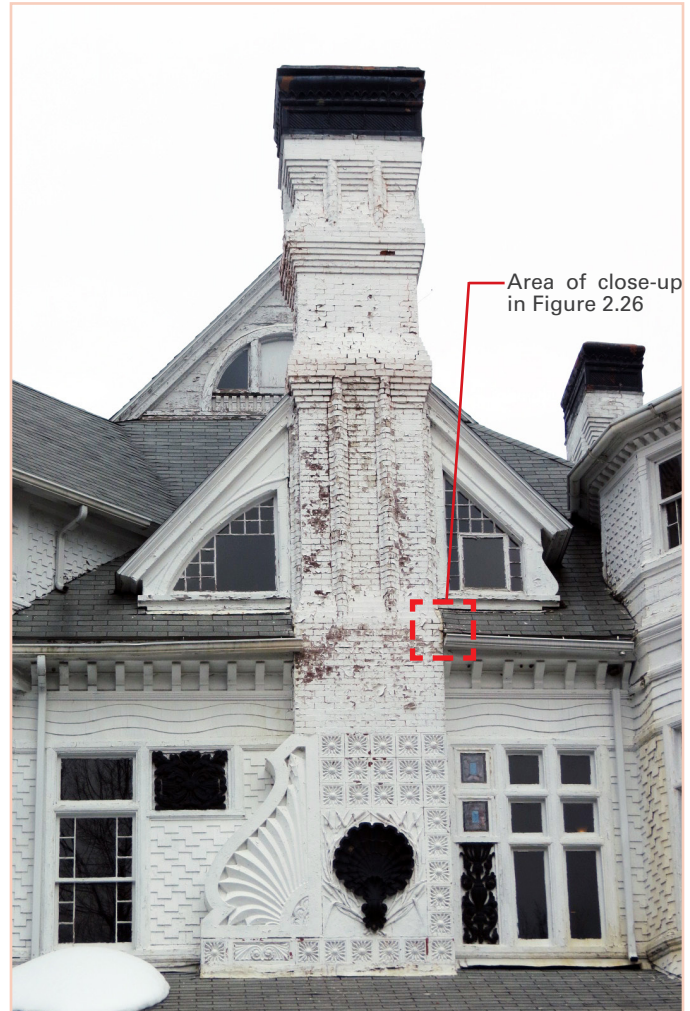
Figure 2.25: South chimney.

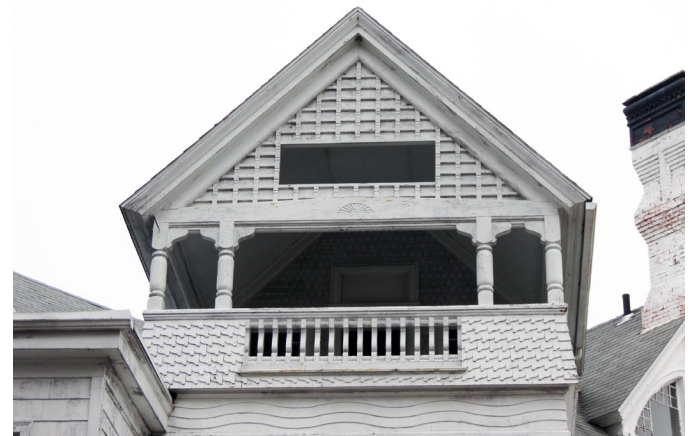
Figure 2.30: Third floor porch at west elevation.

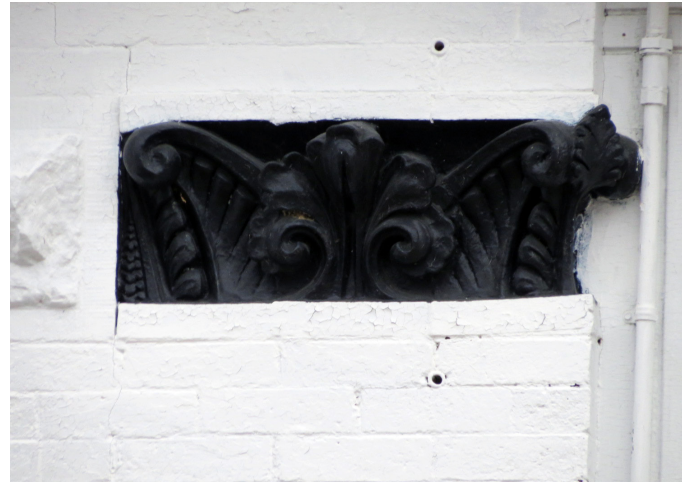
Figure 2.32: Terra cotta unit at the south facade

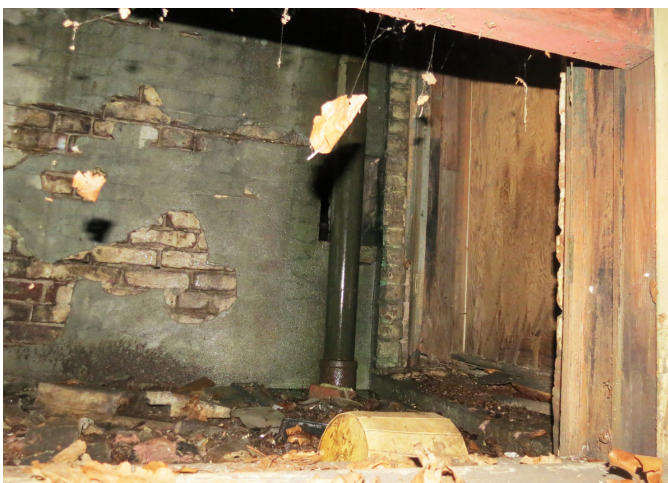
Figure 2.37: Interior view of areaway adjacent to southeast turret.

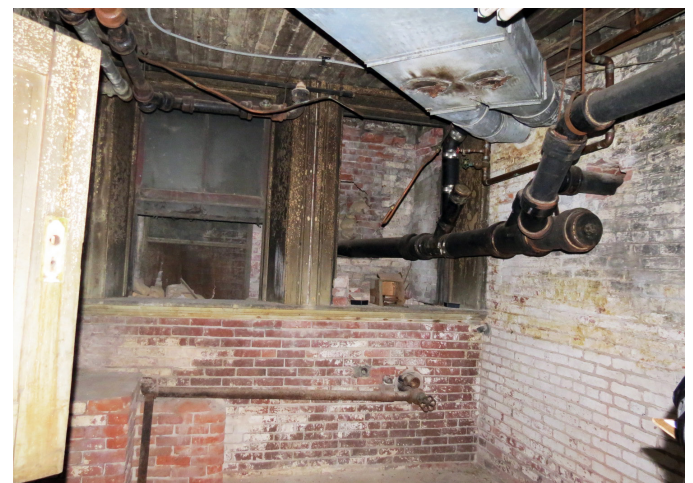
Figure 2.38: Interior view of areaway at the northeast corner, now enclosed by additions.

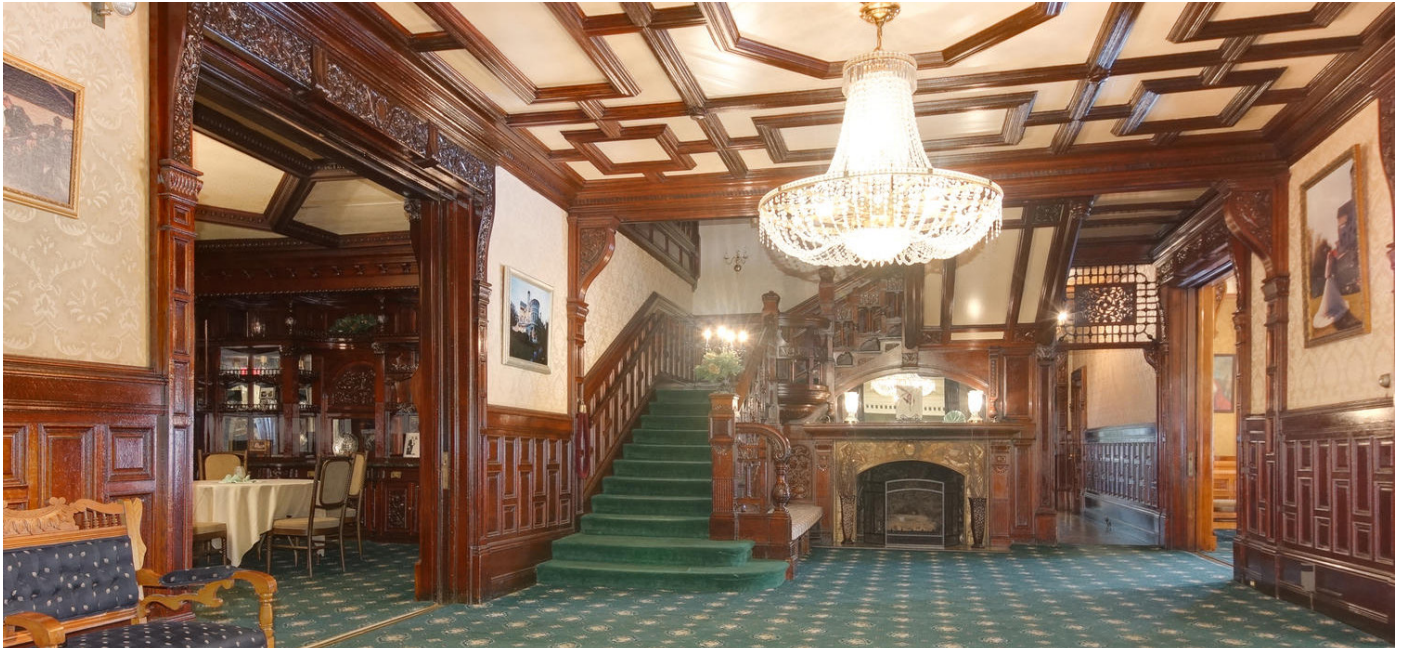
Figure 2.39: View of Entry Hall and Grand Stair beyond.

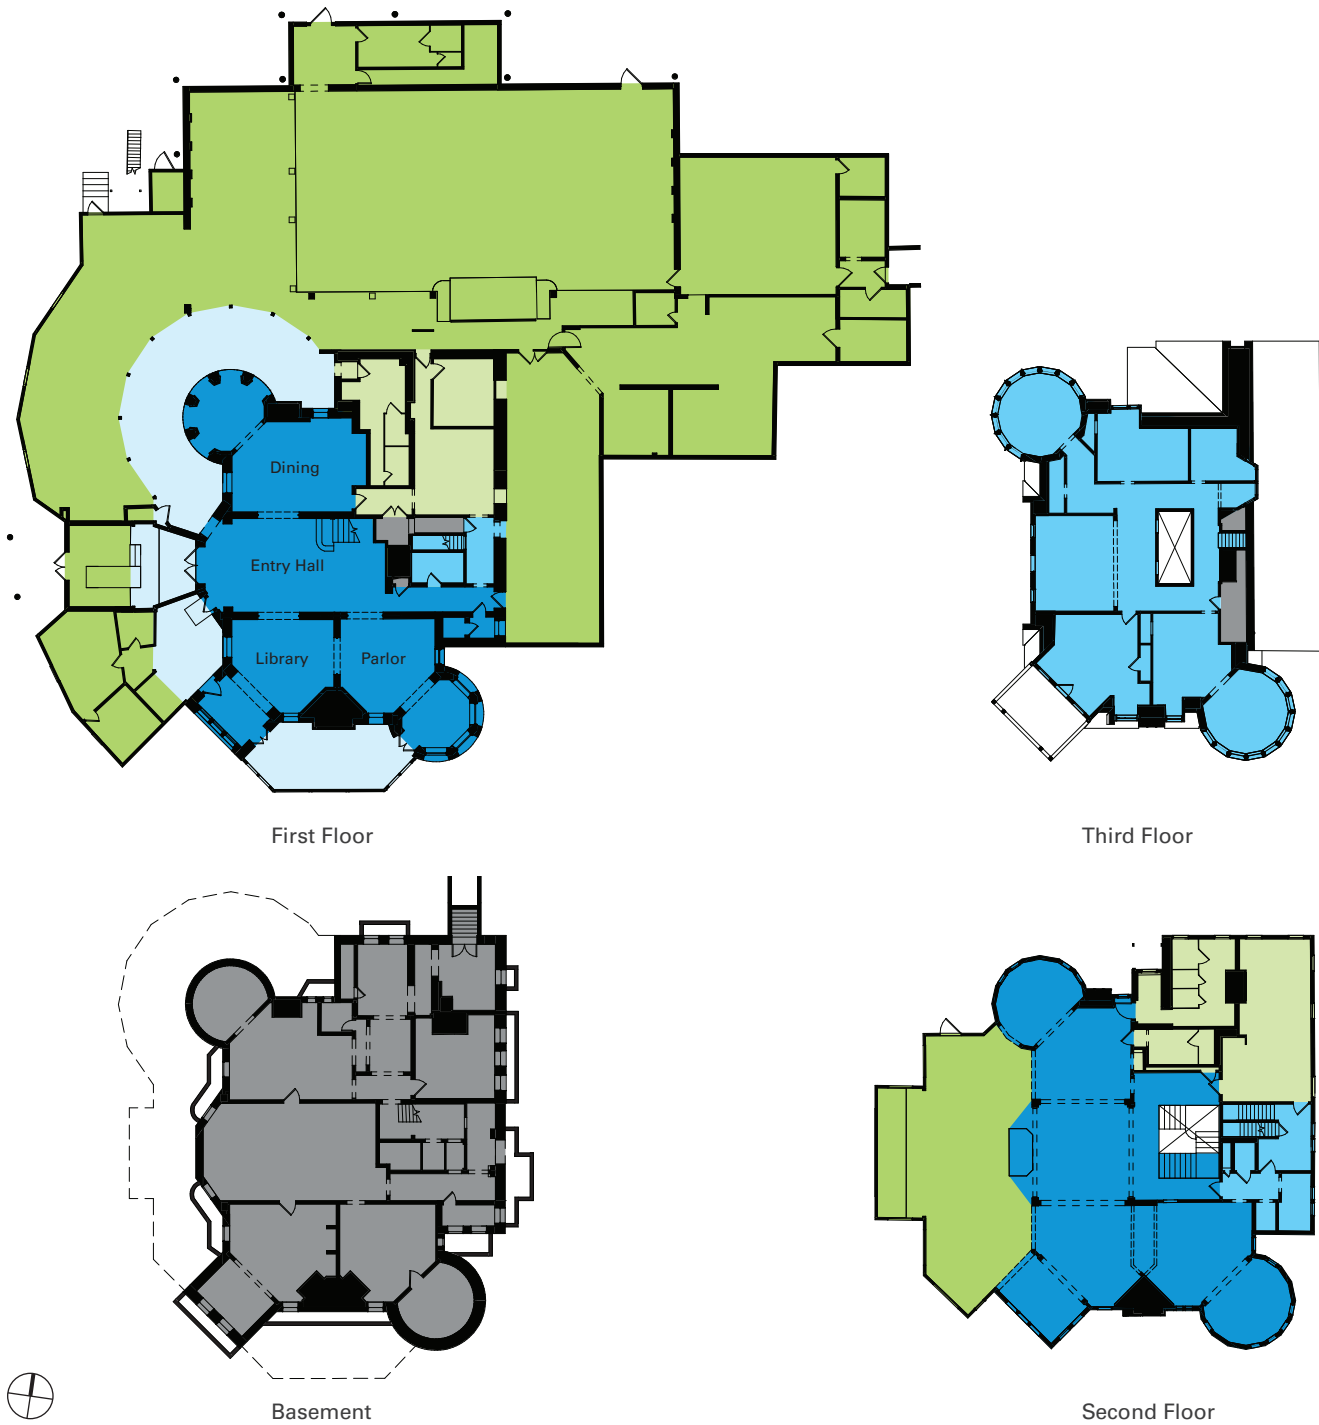
Figure 2.40: Floor Plan Diagrams.

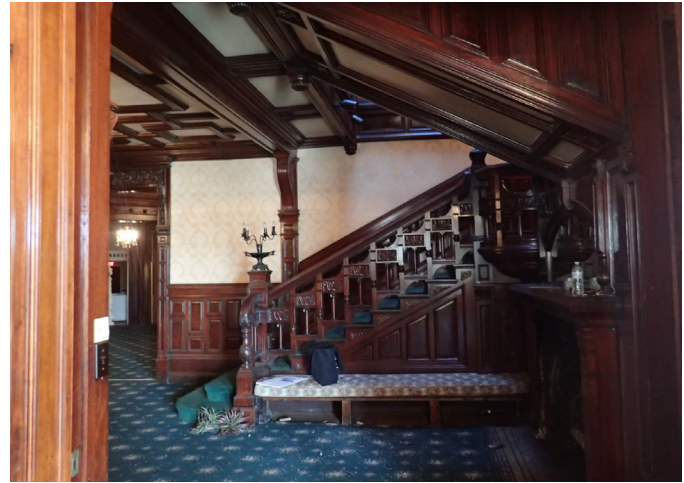
Figure 2.41: Woodwork at entry hall grand stair.

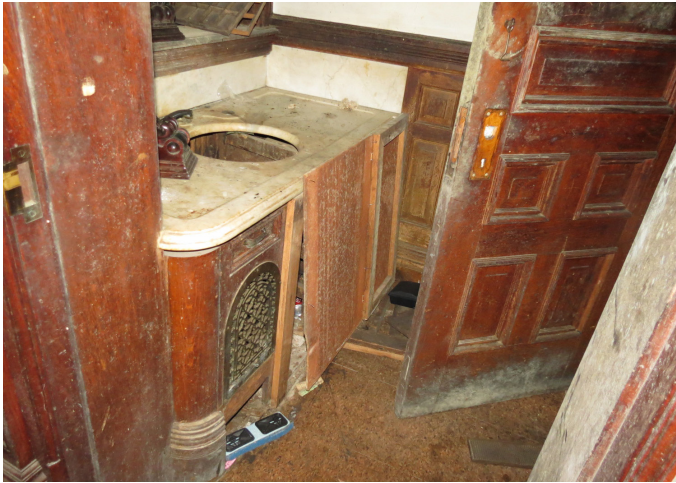
Figure 2.44: Deteriorated woodwork at the first floor bathroom.

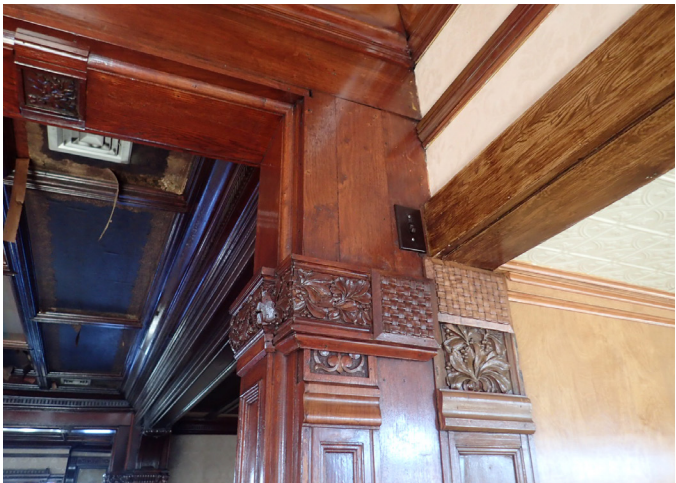
Figure 2.45: Mismatched woodwork at the second floor event space.

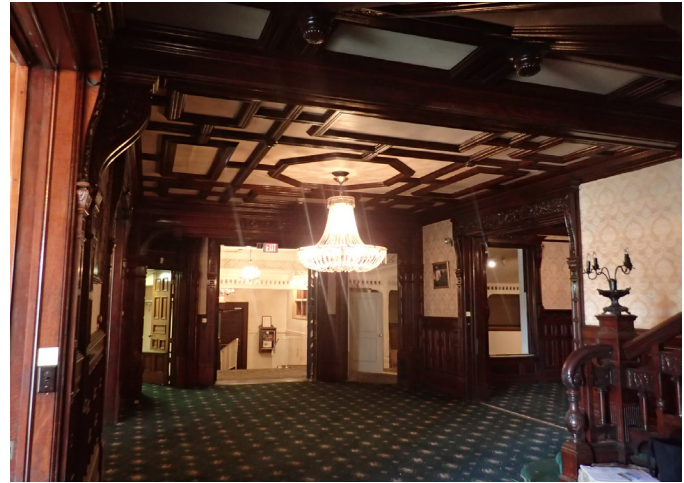
Figure 2.47: Wood trim at Entry Hall.

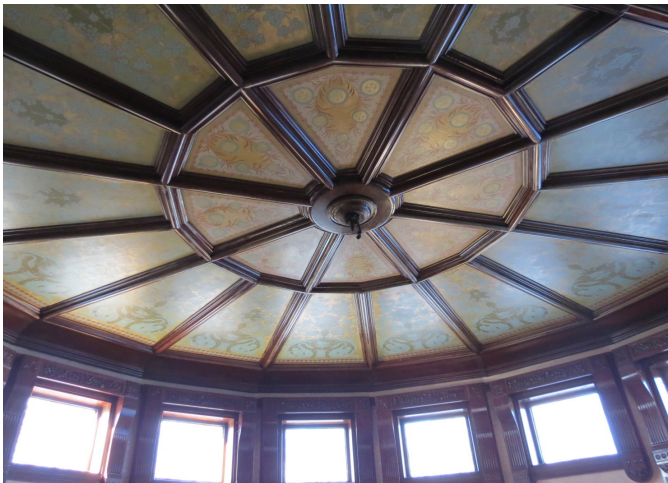
Figure 2.51: Stenciling at second floor northwest turret.

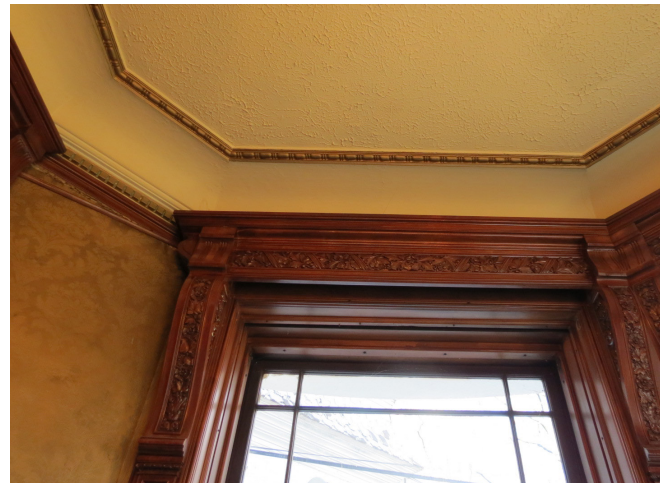
Figure 2.53: Simple plasterwork at southeast turret in Parlor.

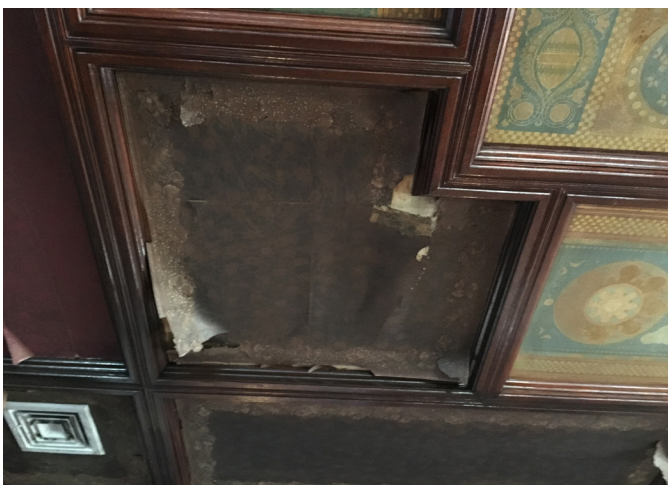
Figure 2.52: Failed replacement panel at second floor.

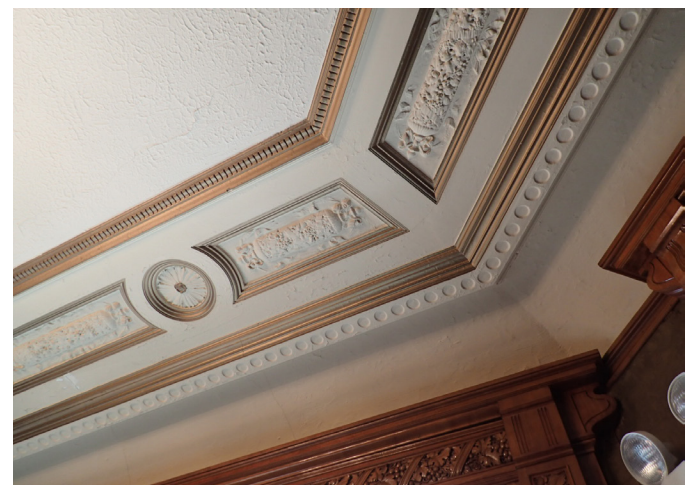
Figure 2.54: Ornamental plasterwork at Parlor.

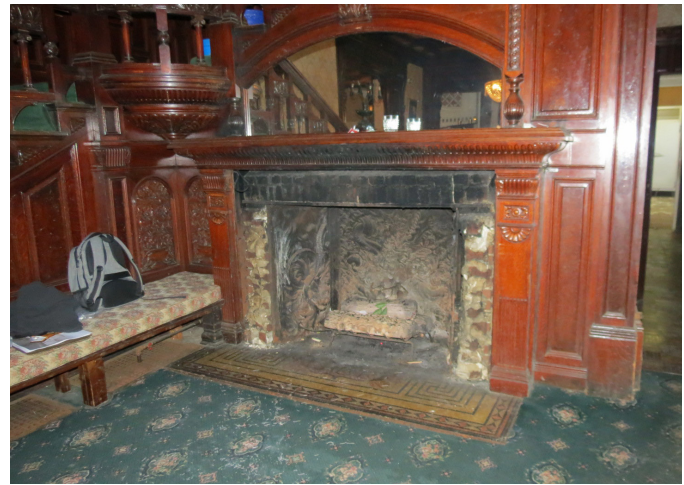
Figure 2.55: Fireplace at Entry Hall, note bronze surround has been salvaged.

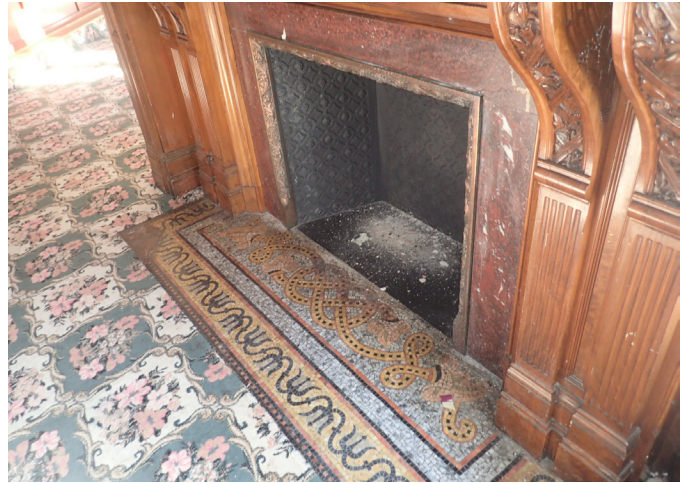
Figure 2.61: Detail view of mosaic hearth with minor damage in upper corner.

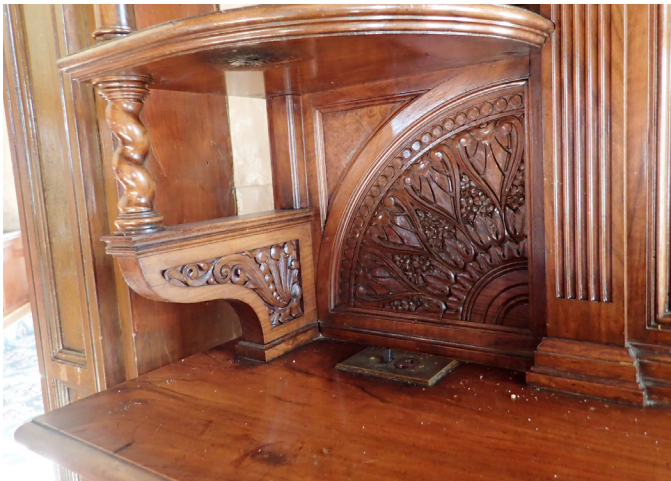
Figure 2.59: Detail of woodwork at fireplace overmantel in photo above.

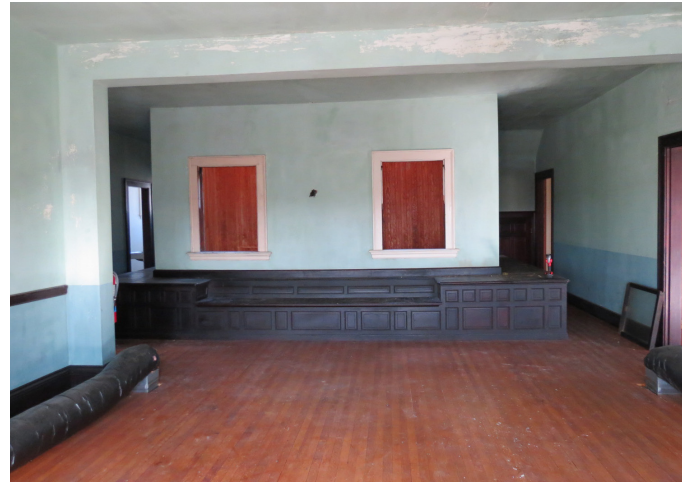
Figure 2.64: Light well at the third floor.

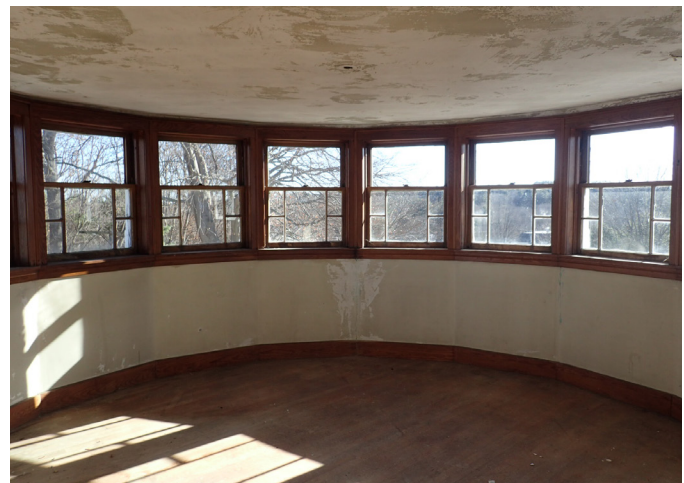
Figure 2.66: Third floor room at southeast turret, note plaster damage at ceiling.

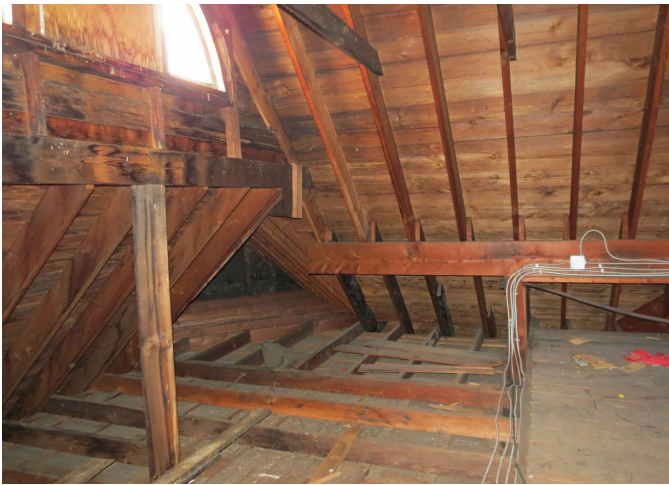
Figure 2.67: Attic framing.

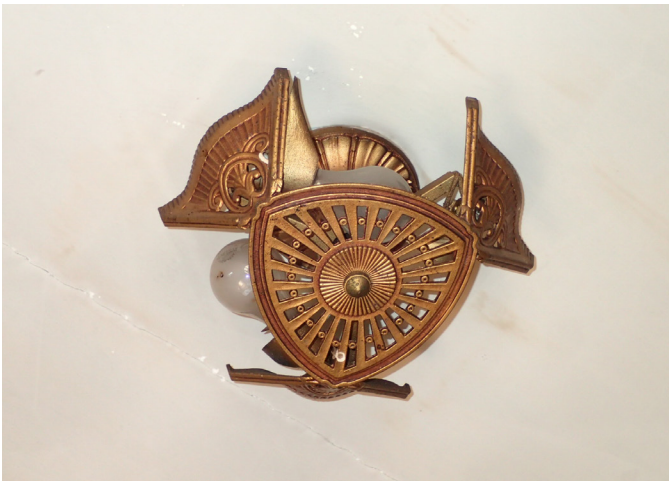
Figure 2.68: Art Deco ceiling mounted light figure.

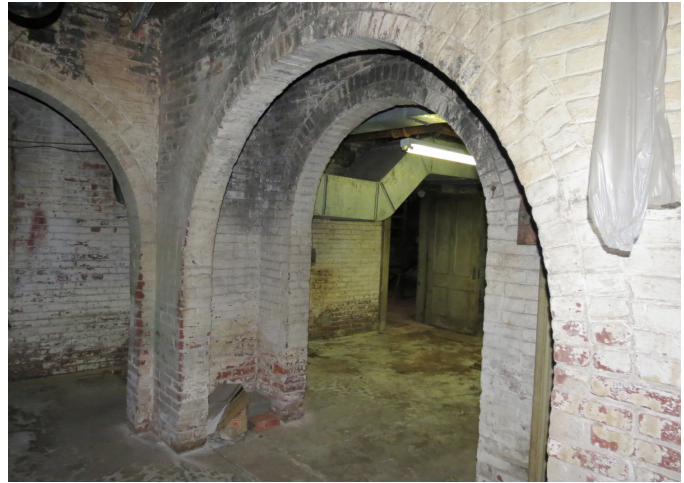
Figure 2.71: Typical brick masonry walls at basement.

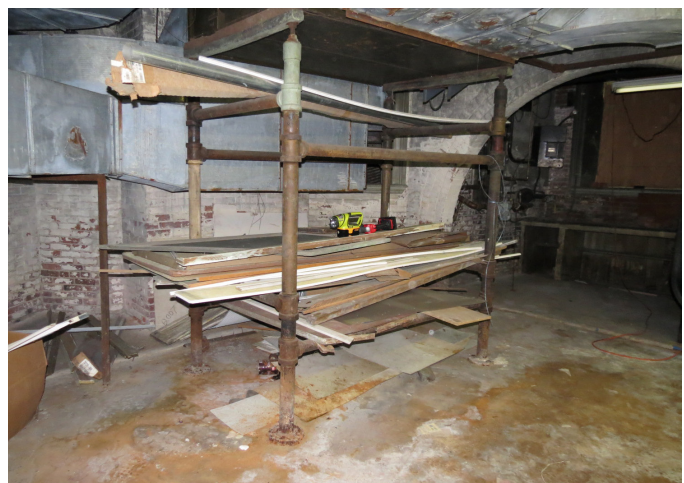
Figure 2.73: Evidence of water damage at basement slab.

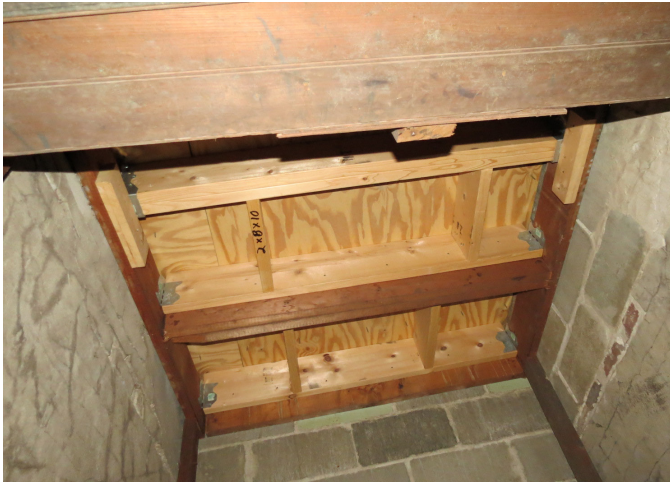
Figure 2.74: Enclosure at original exterior basement stair.

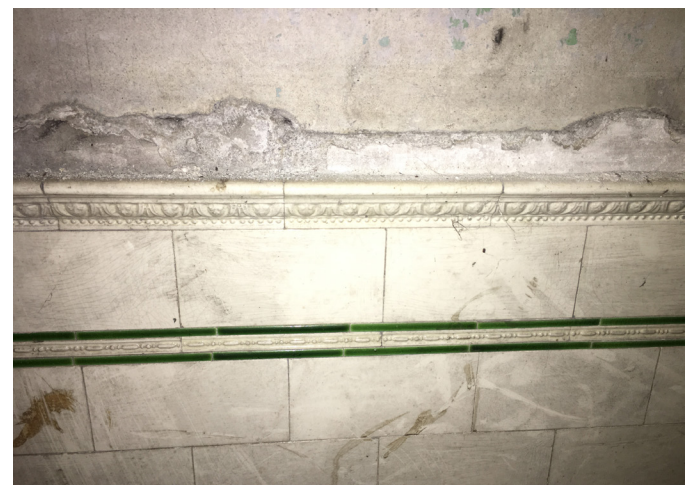
Figure 2.77: Tile at basement bathroom.

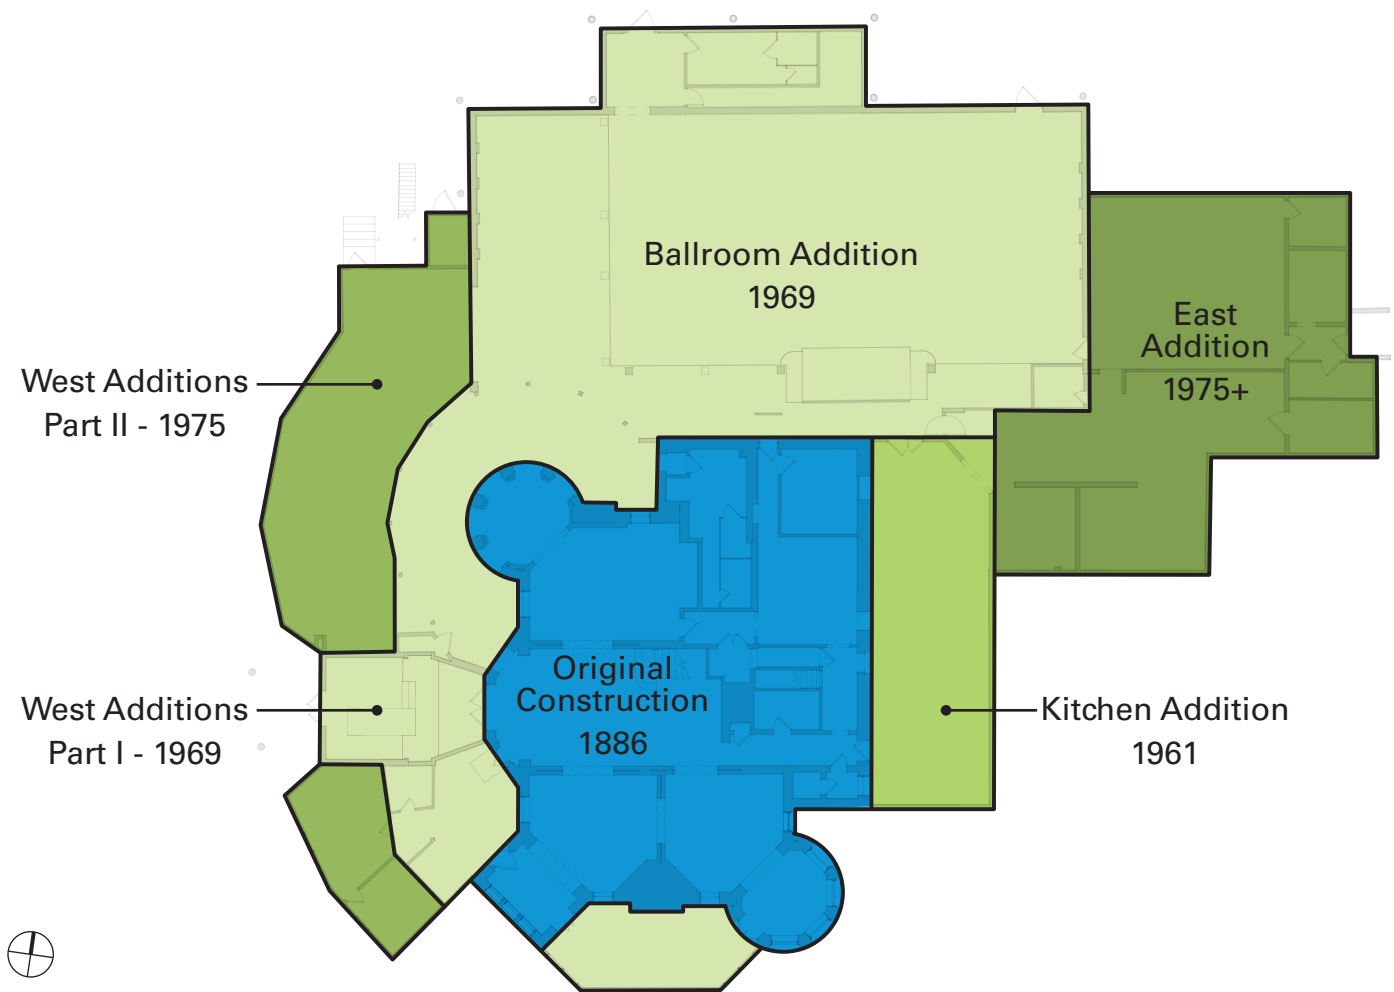
Figure 2.78: Diagram of additions at White Cliffs.

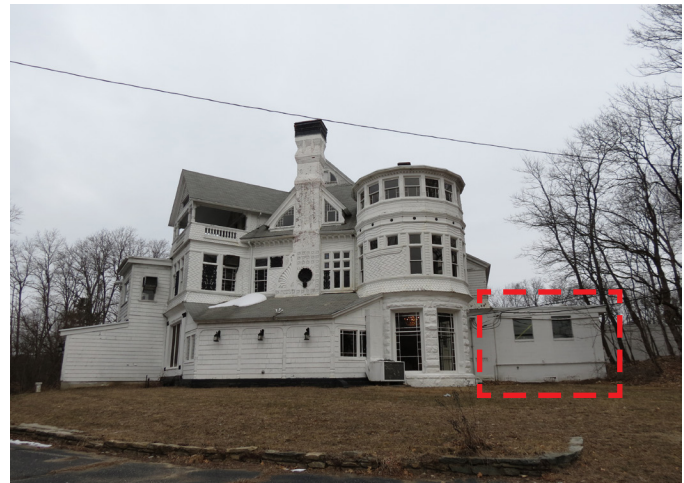
Figure 2.79: Exterior view of the kitchen addition.

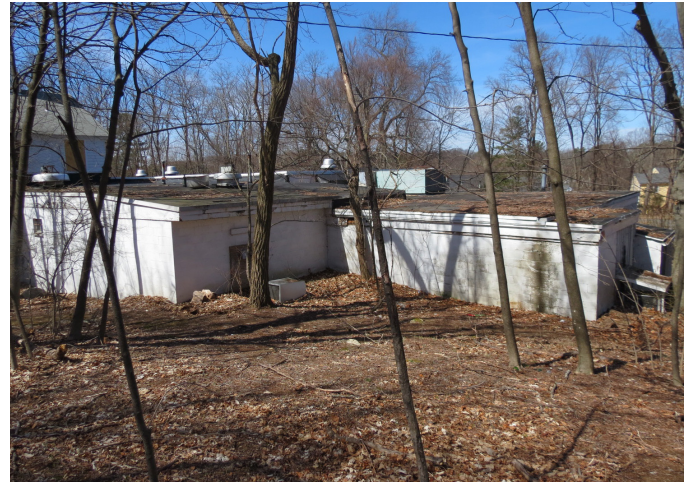
Figure 2.85: Exterior view of east addition.

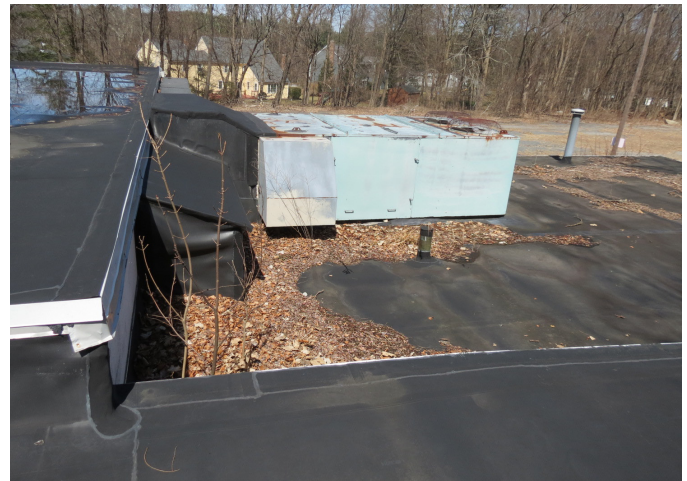
Figure 2.86: Area of active water infiltration at east addition roof.

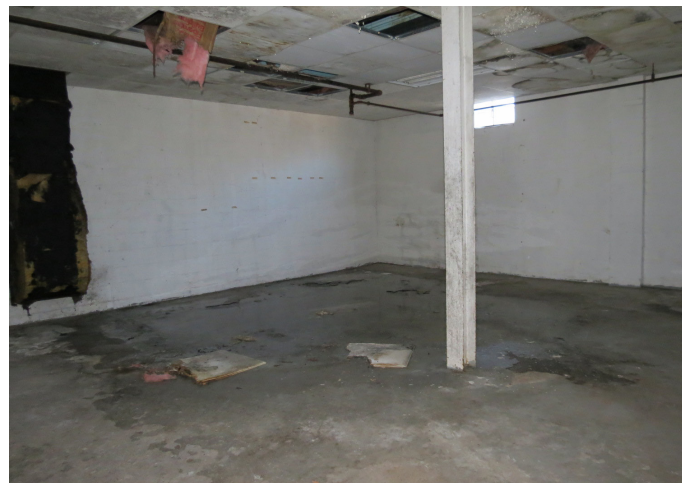
Figure 2.87: Result of active water infiltration at east addition roof.

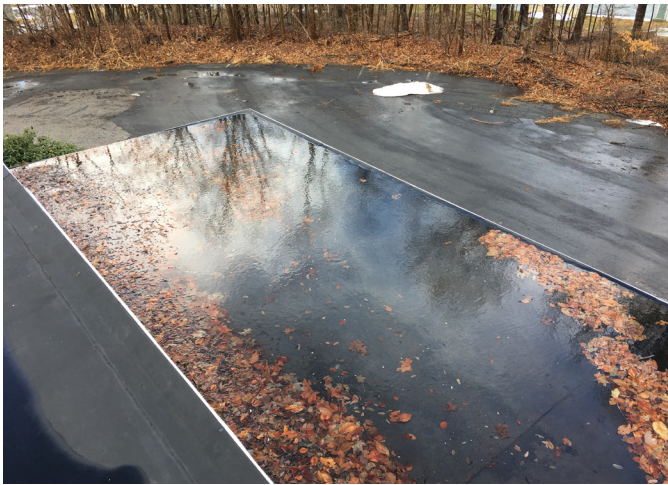
Figure 2.88: Ponding water at the roof of ballroom addition.
