Northborough, MA
White Cliffs Mansion
Assessment and Reuse Study

Submitted To:

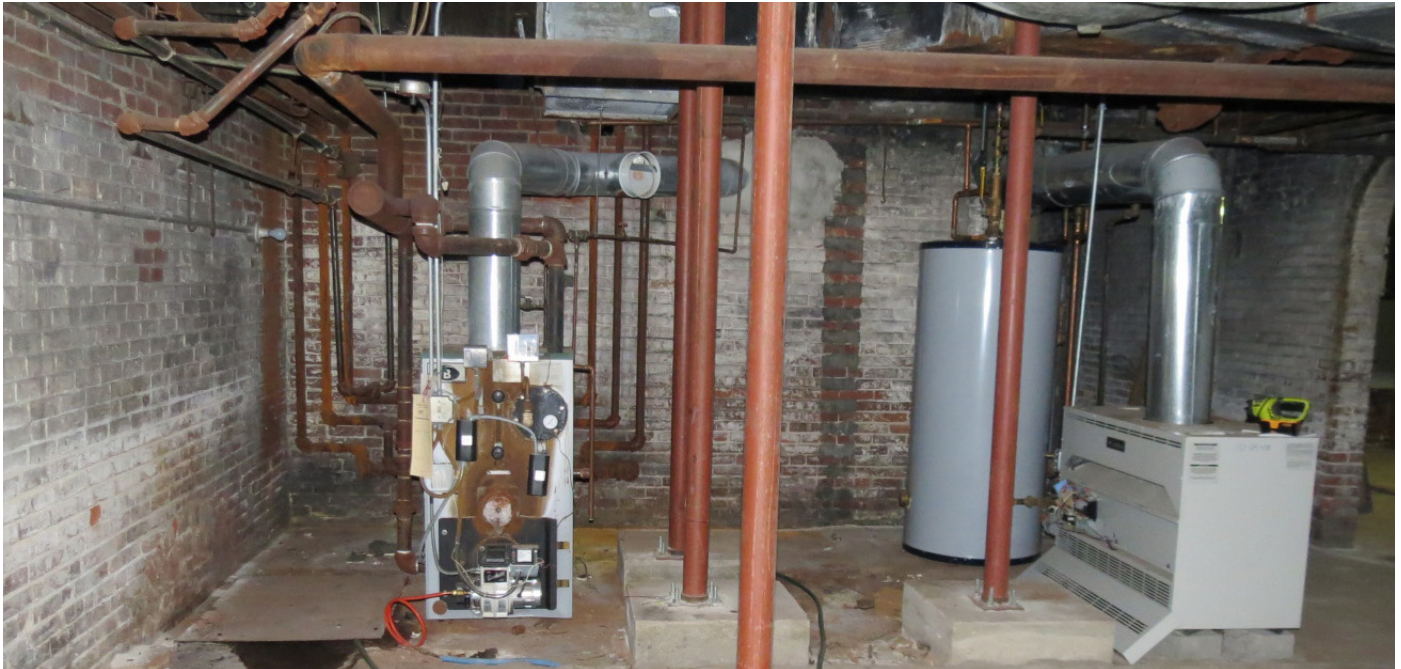
Figure 2.91: View of components of the existing mechanical and plumbing systems at the basement.

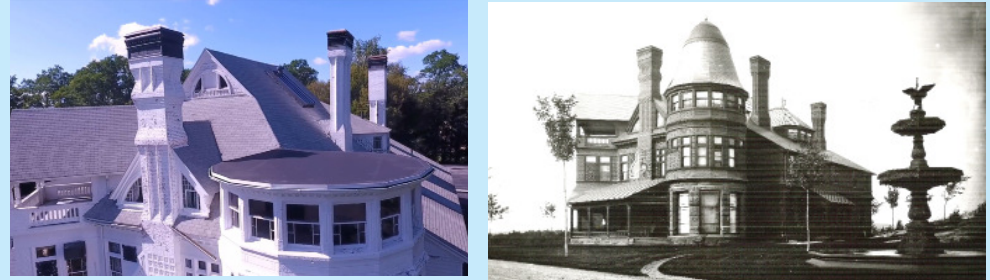
2.	Exterior	Chimneys	Tall, decorative chimneys feature brick and terra cotta ornament.	High

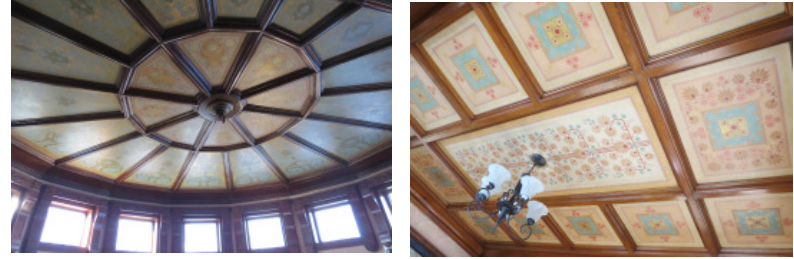
11.	Multiple	Stained Glass	Many of the windows, as well as the laylight above the central stair, contained decorative stained glass panels. The stained glass has been removed and is in storage. Collectively it represents a character defining element.	Medium to High

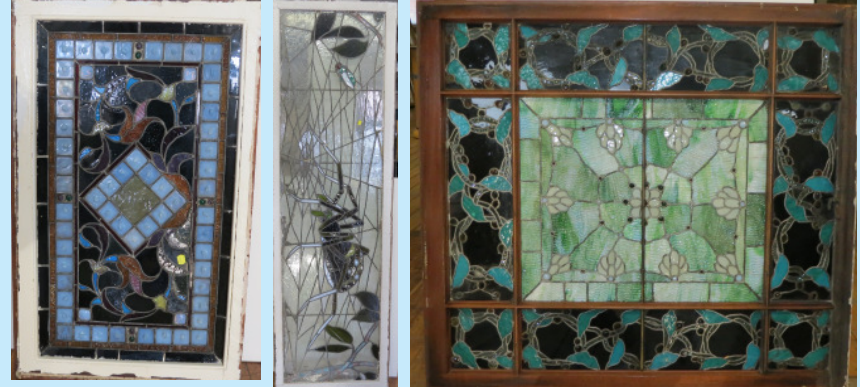
PRIORITIZATION OF EXTERIOR STABILIZATION WORK

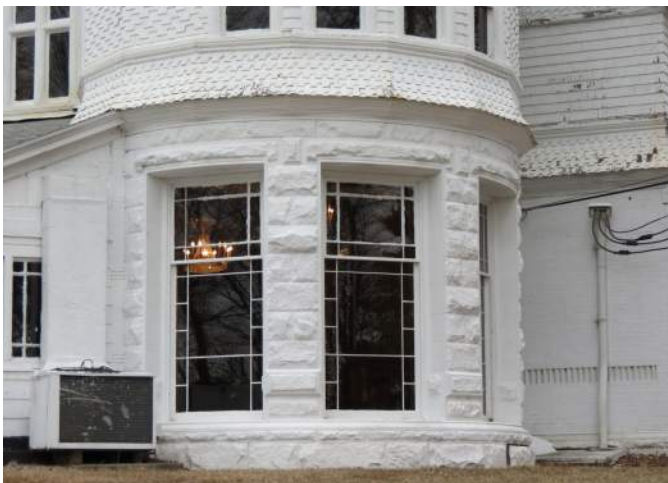
Figure 3.2: Vulnerable first floor windows at the southeast turret.

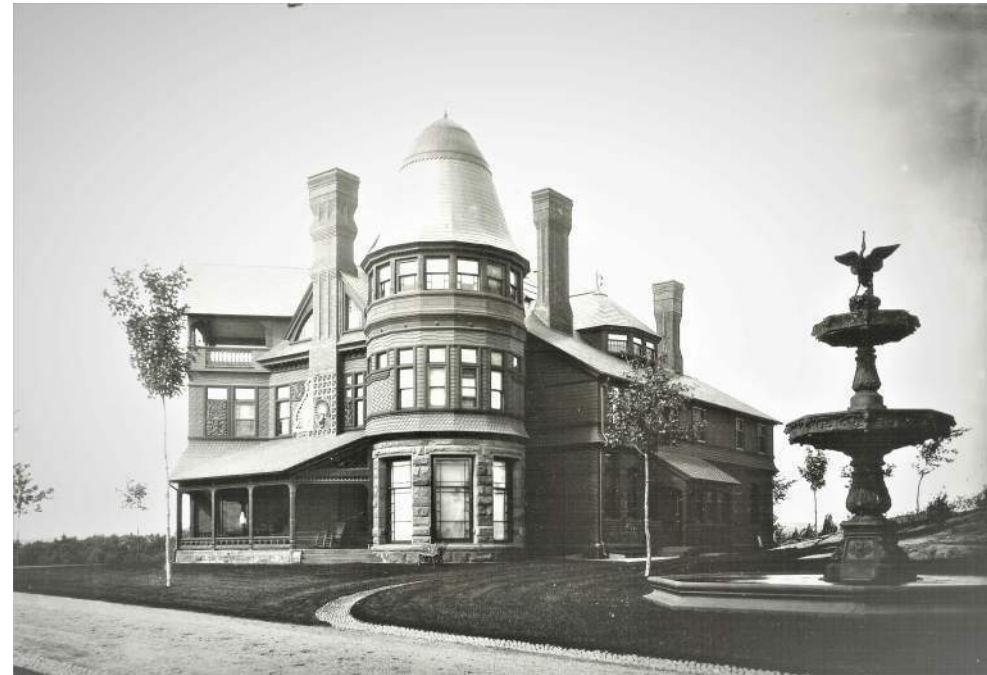
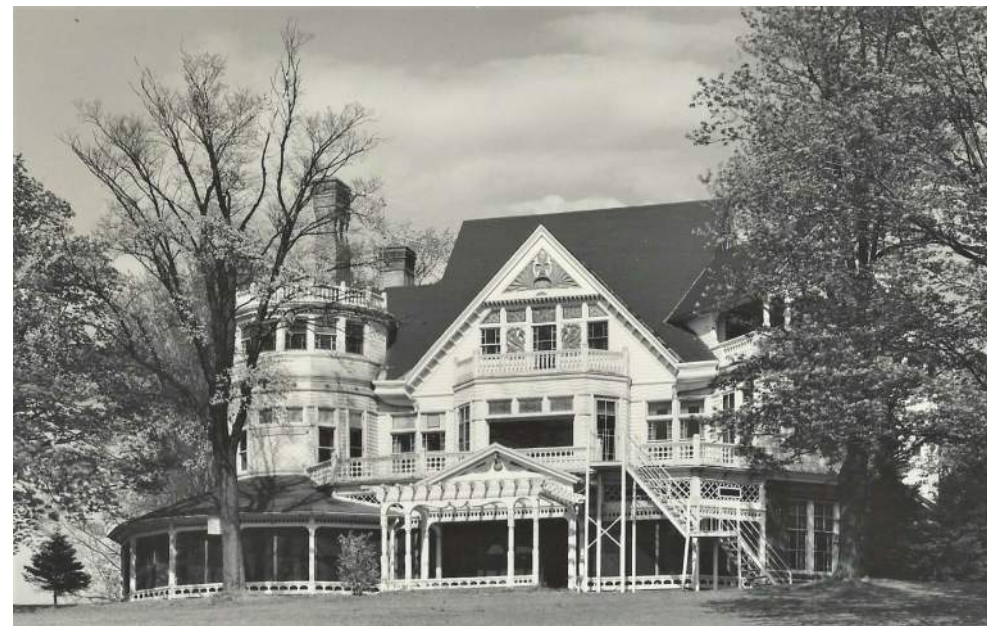
IMAGES: NORTHBOROUGH HISTORICAL SOCIETY

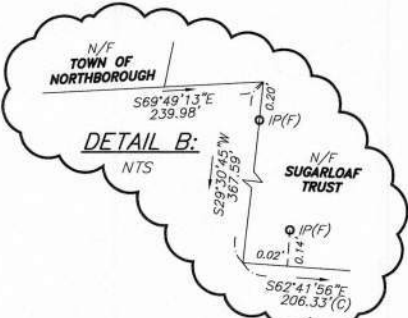
- ZONING LINE SHOWN HEREON IS APPROXIMATE AND HAS BEEN COMPILED FROM THE TOWN OF NORTHBOROUGH GIS.

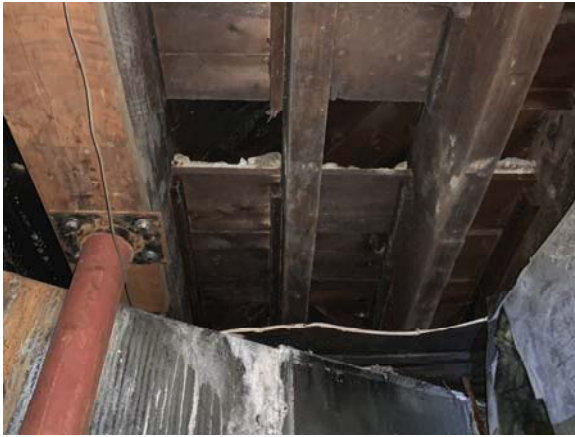
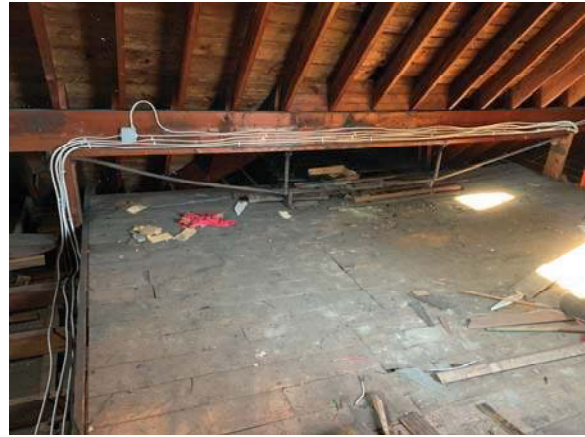
The main roof of the original building is generally the form of a dutch hip, with a number of intersecting gable and shed dormer roofs. The existing rafters are 2x8's and tied with ceiling joists. There is a clear span beam and truss system on the west side of the attic running in the north/south direction that spans between the two primary interior bearing lines of the building (see photo above right). This truss system provides interior support for the long span rafters on the west side of the center gable. There is a bearing wall on the eastern side of the roof that provides interior support for the rafters. Similar to the floor construction, the portions of the original roof framing that were exposed appear to be well constructed and in good condition.

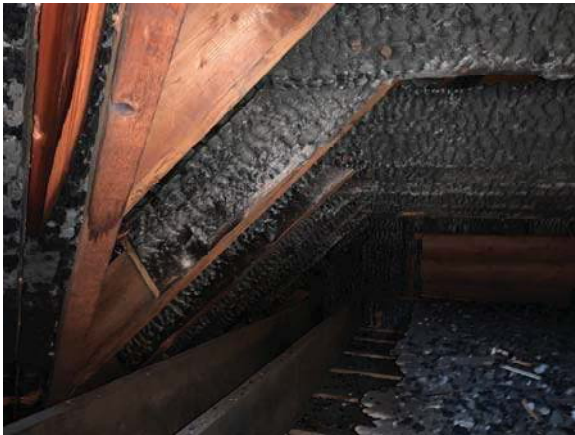
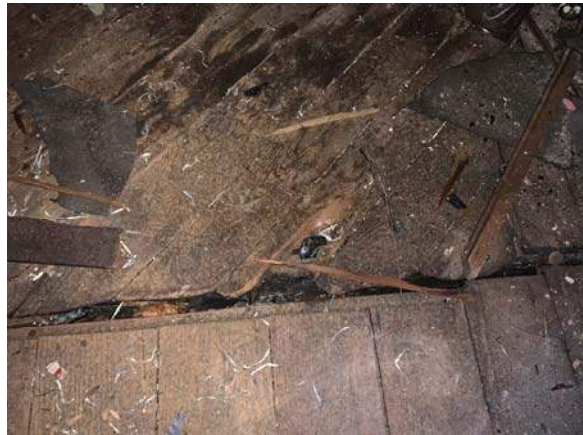
Another area with some fire damage was observed in the attic crawl space on the third floor above adjacent to the east chimney and back stair (photo above right). The extent of the damage could not be determined since the framing is mostly hidden by the ceiling and floor sheathing. This area will need to be investigated further and some portions of floor or ceiling removed in order to observe the existing framing.

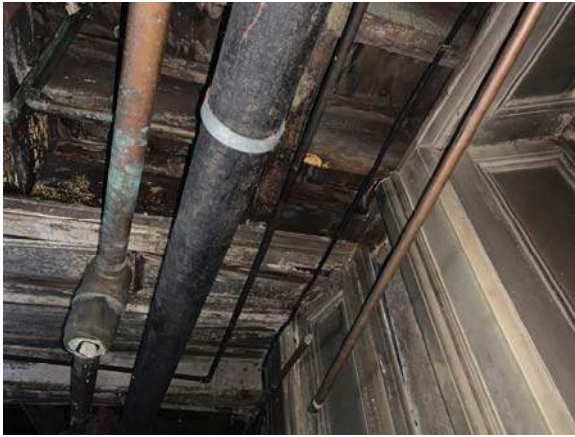
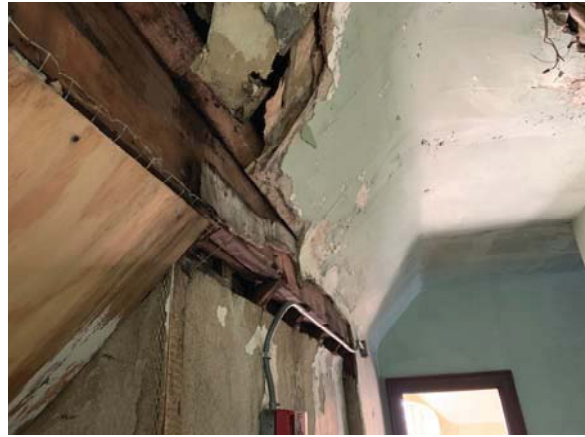
Localized Deterioration at Roof Leaks

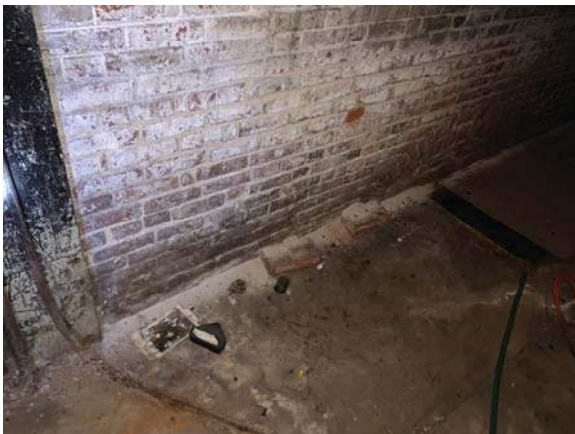
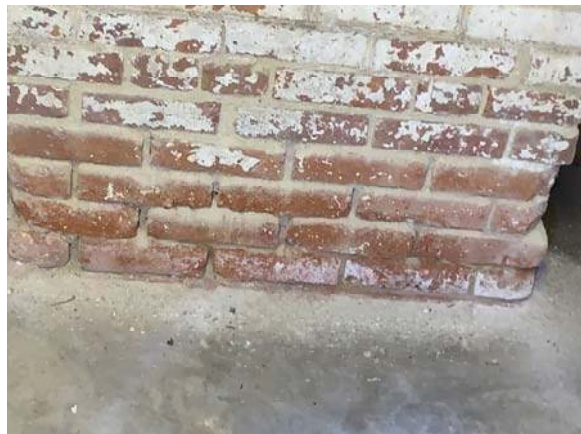
Suitability for Future Use

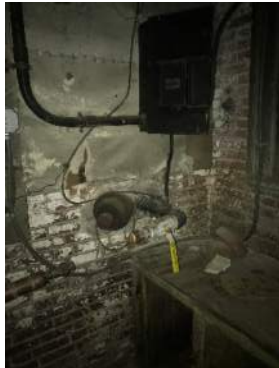
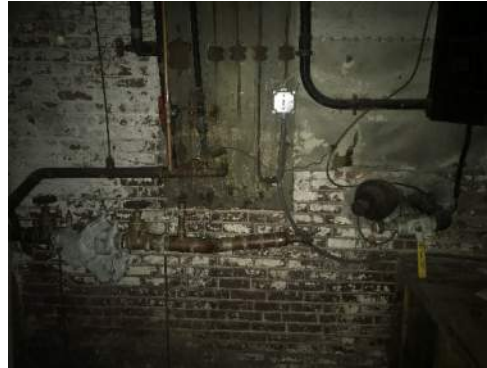
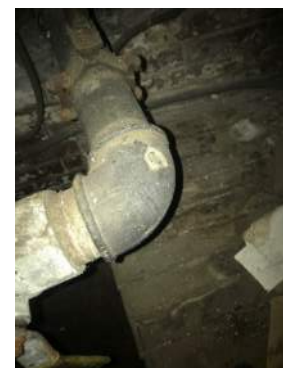
The age of the service is unknown. The inside surface of the pipe shall be examined to determine if corrosion or sediment compromised the service performance. Additional piping shall be tested for possible lead content.

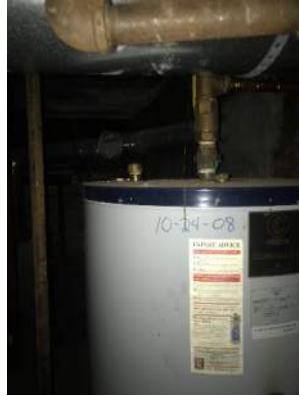
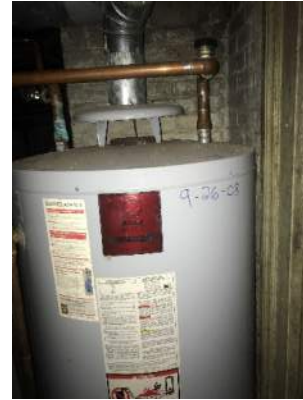
Sanitary Sewer System

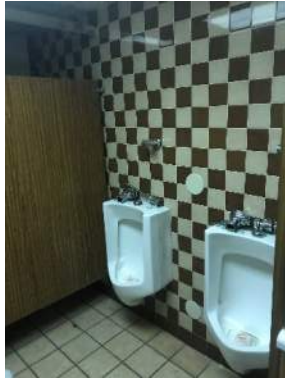
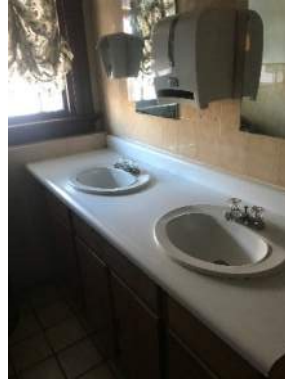
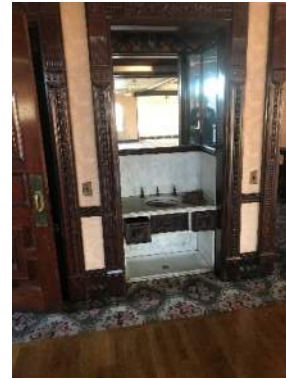
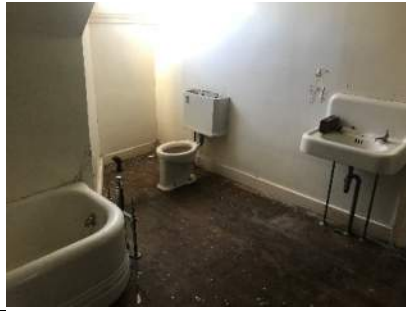
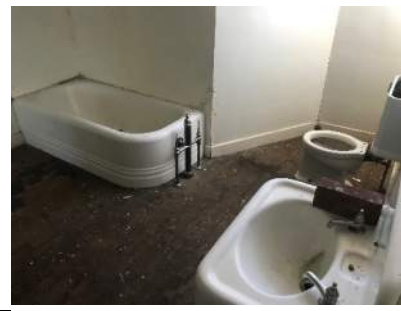
2.2 Plumbing System Conditions Summary

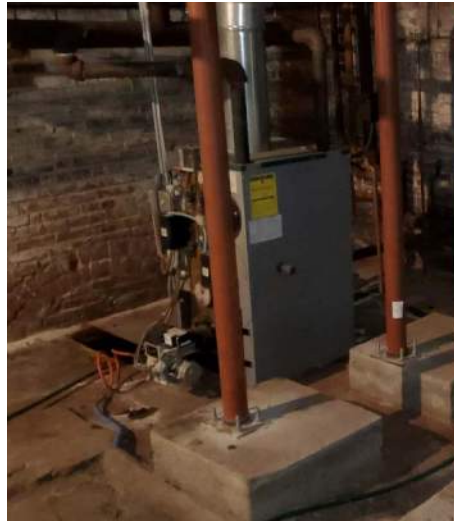
Primary Boiler Serving HVAC System

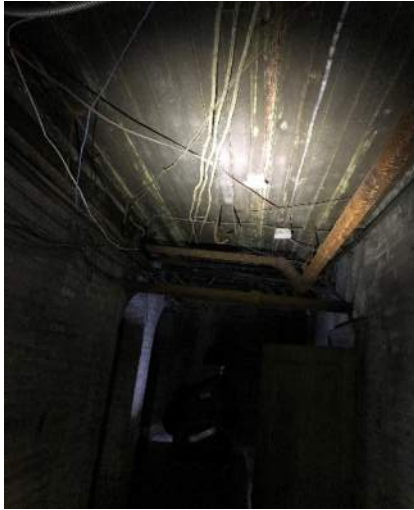
Existing wiring through corridor

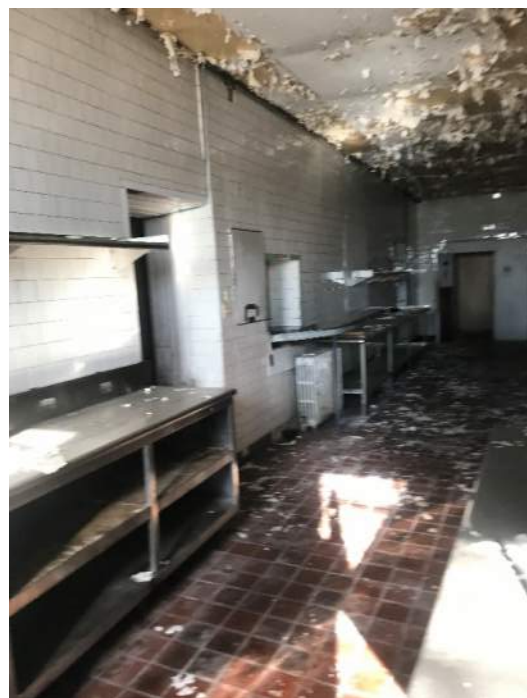
Electrical sub panel in the kitchen
