DATE SUBMITTED: 11.1.2021					
NAME OF PROJECT: Preliminary Design for Pedestrian Access Over the Assabet River					
Aqueduct Bridge					
NAME OF APPLICANT: Northborough Trails Committee					
CONTACT ADDRESS: Planning Office, Town Hall, 63 Main Street,					
CONTACT TELEPHONE: 508-393-5015					
CONTACT EMAIL ADDRESS: mmcdonald@town.northborough.ma.us					
SPONSORING ORGANIZATION: Northborough Trails Committee					
CPA CATEGORY:  ☐ OPEN SPACE/RECREATION ☐ HOUSING ☐ HISTORIC					
LOCATION: TOWN LAND SCHOOL LAND PRIVATE LAND					
AMOUNT OF CPA FUNDS REQUESTED: \$					
OTHER FUNDING SOURCES:					
TOTAL COST OF PROJECT: \$ \ 33, 656,00					
BRIEF DESCRIPTION OF PROJECT, INCLUDING ANY CONSTRUCTION REQUIRED:					
The application is to hire an engineering firm to conduct the preliminary design for allowing pedestrian access over the Assabet River Aqueduct Bridge.

Re: Application for Funding for Preliminary Design for Pedestrian Access Over the Assabet River

Assabet River Bridge – Evaluation for Use as Part of a Public-Use Path

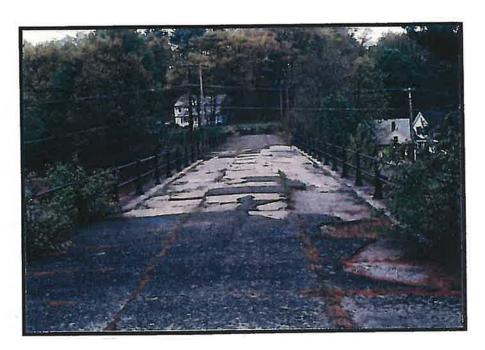
5. Deck Surface Looking West

• The outer concrete topping slab and asphalt topping are severely deteriorated or missing over most of the area of the bridge deck. Vegetation is growing from within cracks and spalls in this surface. This topping slab and asphalt must be completely removed. The removal of these non-structural components has the advantage of reducing the dead load on the steel beams that support the remaining bridge deck.

- Verify the assumed steel-beam section properties by field measurements. If the result of the
  verification is positive, then remove the existing 4" concrete/granolithic topping slab,
  asphalt, and iron railings. Repair the surface of the underlying concrete, and place a
  pedestrian-traffic-bearing waterproofing membrane over the repaired concrete. Install a
  new historically appropriate and code-compliant railing by anchoring posts to the existing
  granite edge stones. Perform other repairs and modifications, common to all options, as
  described below.

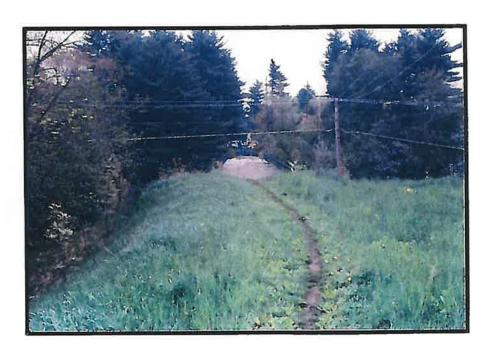
6. West Approach

- Vegetation sprouting from the ground around the stairways and chain-link fences at the ends of the bridge obstructs access and will have to be removed to allow pedestrian access.
- Gates in the fences at the ends of the bridge will have to be unlocked or removed to accommodate the proposed public-use path. The damaged fences should be repaired and remain in place to act as fall protection along the tops of the stone stairway walls and wingwalls at the bridge ends.

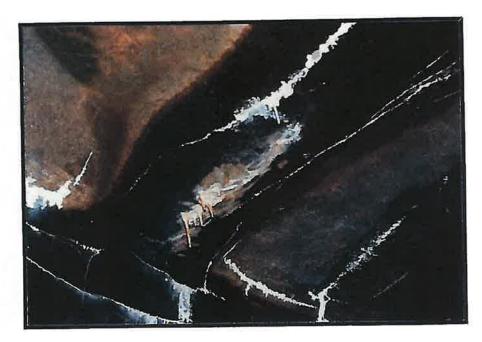
9. Aqueduct Ceiling

- The interior surfaces of the invert, walls, and underside of the brick roof and steel beams are covered with mortar. We measured the thickness of the mortar at a spall in the wall; the total mortar thickness is 1 3/8", with the outer 1/8" appearing to be a different, finer material compared to the inner 1 1/4" of mortar.
- Mortar on the underside of the roof and beams is completely intact. Some of the mortar is cracked, but we observed no spalls on the underside.
- Efflorescence is present on mortar under the steel beams, indicating past leakage. This efflorescence is mainly white in color. At a few locations, there is some brown staining of this material, indicating some rusting of embedded beams and strap plates.
- Active leakage through the mortar below the roof beams was occurring at a few locations.
