FY2025 APPLICATION

DATE SUBMITTED: October 24, 2023
NAME OF PROJECT: Structural Restoration of the Steeple on Historic Property
NAME OF APPLICANT: First Parish Northborough Unitarian-Universalist Church
CONTACT ADDRESS: 40 Church Street, Northborough, MA
CONTACT TELEPHONE: 913-219-7394
CONTACT EMAIL ADDRESS: gordonhart@gmail.com
SPONSORING ORGANIZATION: First Parish Church
CPA CATEGORY: <input type="checkbox"/> OPEN SPACE/RECREATION <input type="checkbox"/> HOUSING <input checked="" type="checkbox"/> HISTORIC
LOCATION: <input type="checkbox"/> TOWN LAND <input type="checkbox"/> SCHOOL LAND <input checked="" type="checkbox"/> PRIVATE LAND
AMOUNT OF CPA FUNDS REQUESTED: \$210,000
OTHER FUNDING SOURCES: Massachusetts Preservation Projects Fund, and Church
TOTAL COST OF PROJECT: \$300,000
BRIEF DESCRIPTION OF PROJECT, INCLUDING ANY CONSTRUCTION REQUIRED:
<p>The steeple continues to suffer from rainwater leakage. The congregation plans, at its own expense, to hire a contractor to replace defective materials on the steeple exterior and reseal that exterior to prevent future leakage. It hopes to have this work completed by the end of the calendar year, 2023. This steeple is part of our M

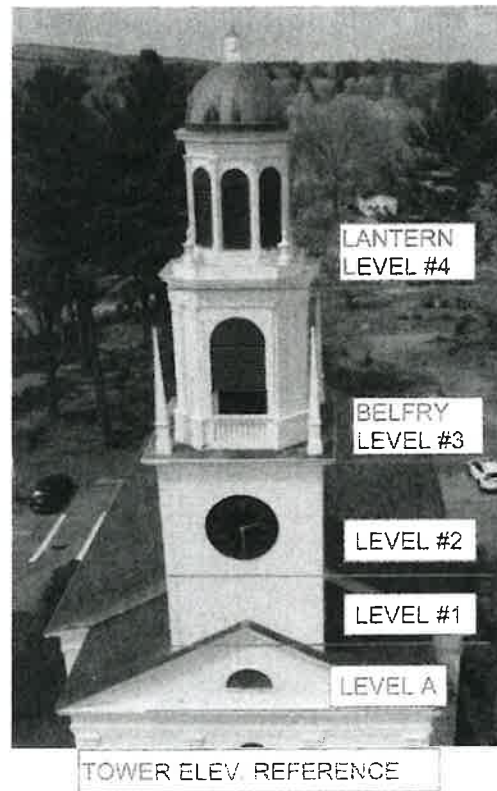
Figure 1: Tower Levels Reference Figure

The First Parish Church in Northborough has a wood framed tower that starts at Level A (attic space) and extends up four more levels. At the base of the tower, where the clock is present, there are two wood framed platforms along the interior, and a vinyl siding envelope along the exterior. At the belfry level, there is another platform that supports the bell and cradle within the tower, and the outside displays (4) wooden louvers, (4) wooden pinnacles, a decorative balustrade, and an EPDM rubber membrane roof. Level #4, the lantern level, has a less accessible platform along the interior where the majority of the cellular equipment is installed. The exterior of the lantern level shows (8) louvers along each octagonal face, (4) smaller wood pinnacles, and copper flashing at the flat and domed roof. Please refer to Figure 1 for the interior tower levels with respect to the tower envelope.
